The River Action Plan (RAP) has been prepared to provide a basis for rehabilitation works and a summary of baseline conditions to reference future works against. The document was prepared in partnership between the Peel-Harvey Catchment Council and Urbaqua, with funding provided by the Aloca Foundation under the Connecting Corridors and Communities: Restoring the Serpentine River project. The RAP addresses approximately 38 km of river from the Lowlands Nature Reserve to the Peel-Harvey Estuary, divided into eight (8) reaches that vary from meandering natural channels, to artificial drains to estuarine systems.

The RAP was prepared based on field inspections of the reaches and desktop analysis of aerial imagery and previous investigations. Each reach was assessed in accordance with the Department of Water and Environmental Regulation's *River Restoration Manual* (WRC, 1999), specifically the Pen-Scott method that grades foreshore between grades A (pristine) and D (ditch). Scoring of the foreshore condition allowed for determination of priority areas for rehabilitation.

Peel Harvey Catchment Council - Serpentine River Action Plan Figure 1 - Serpentine River Action Plan Reaches

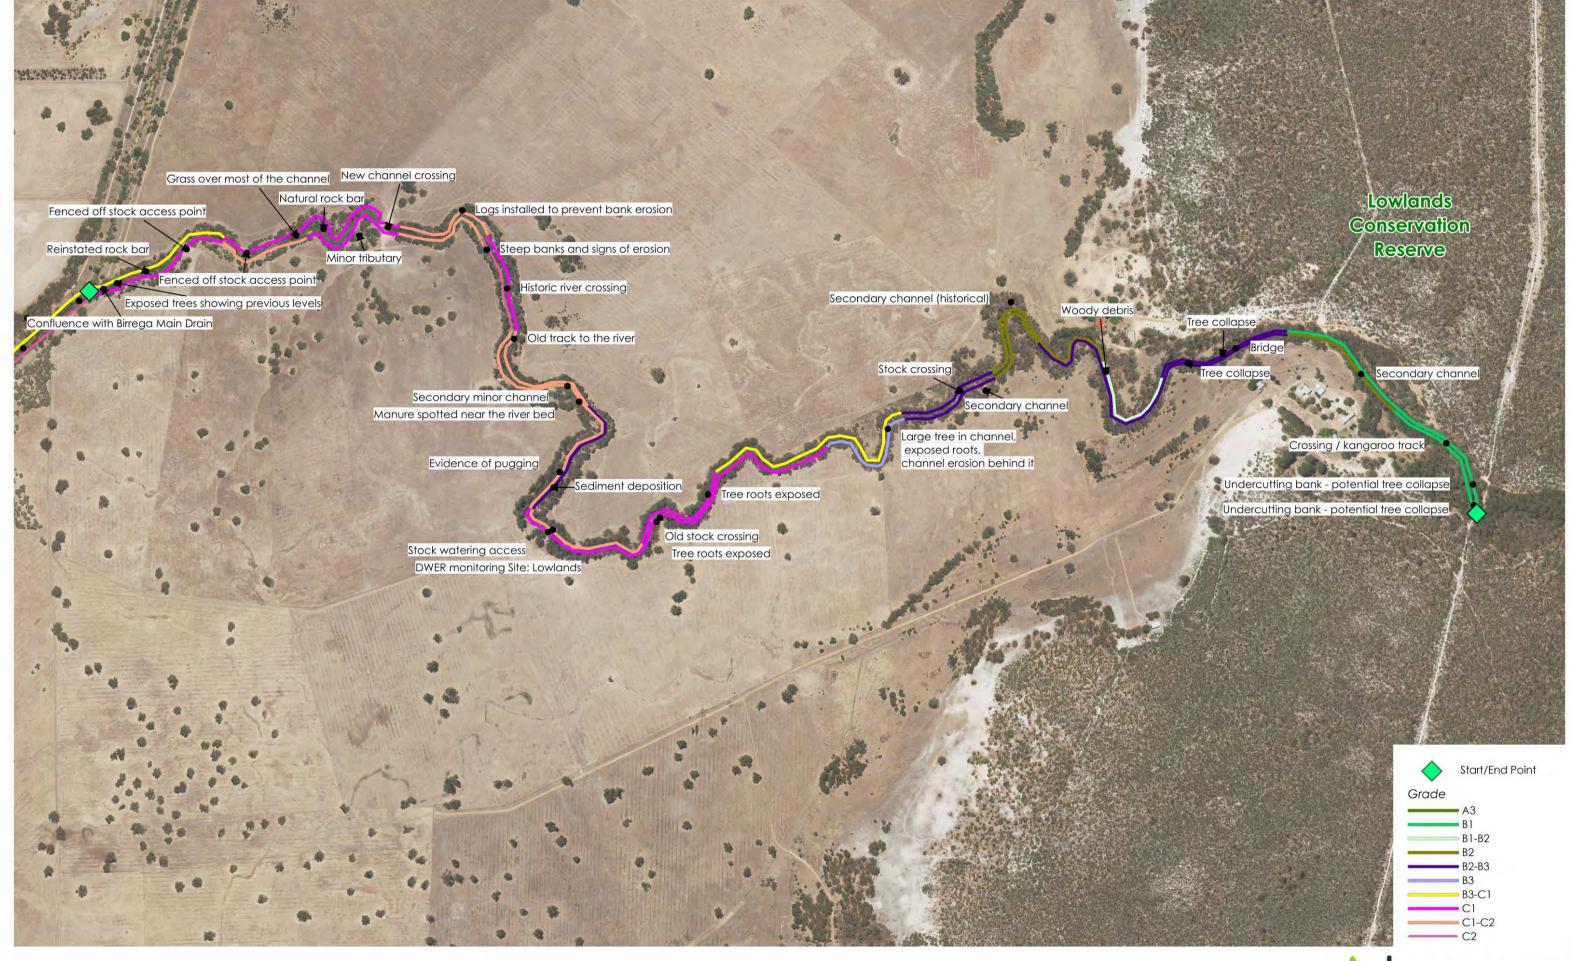
Peel Harvey Catchment Council - Serpentine River Action Plan Figure 7 - Reach 1 Condition Map

General Foreshore Condition	Assessment of the foreshore conditions (as per the methodology outlined in Appendix 1), ranges from relatively good (B1 - degraded) to erosion prone (C2 - soil exposed). The general trend is decreasing condition downstream away from Lowlands associated with reduced riparian and verge vegetation condition and increased bed and bank instability. The initial reaches near Lowlands Reserve represent reference vegetation and stream cover conditions for the upper reaches of the Serpentine River, though minor erosion and bank collapse was noting in these areas.
Vegetation Cover and Stream Health	Riparian vegetation is dominated by mature trees, providing a near continuous canopy along the reach with good shading and woody debris within the channel. The quality of the understorey however decreases considerably downstream from Lowlands Reserve. The mid-storey and understorey in middle and lower sub-reaches are degraded, with bare ground and invasive grasses noted in many locations. The density of mature, large trees was also noted to decrease downstream, though improving near the Birrega Main Drain confluence. Verge vegetation (beyond the riparian zone) consists generally of bare ground with some scattered trees. There is a diversity of habitats along the reach, highlighted by DWER's river health condition assessment (Nov 2017) that noted signs of native fish species recruitment.

Weeds	Weeds were observed throughout the reach, particularly in the middle and downstream reaches where invasive grasses were prevalent on banks and within the channel. The common species observed were kikuyu and couch grass, with some buffalo grass near the homestead. Arum Lily, Bridal Creeper and Watsonia were noted throughout the reach, including on the fringe of Lowlands Reserve.
Erosion	Channel instability and lateral movement is a historical characteristic of this reach, demonstrated by the presence of paleo channels. Field inspections confirmed active erosion along the majority of the channel, corresponding with bed incising at the downstream end and bank retreat on meander bends (with trees undercut and exposed). The lack of understorey increases the potential for bank erosion. At the downstream end, channel incising has led to a deep main channel with flows unlikely to connect with fringing wetlands. Sediment deposition (with invasive grasses) was noted in the middle sub-reaches.

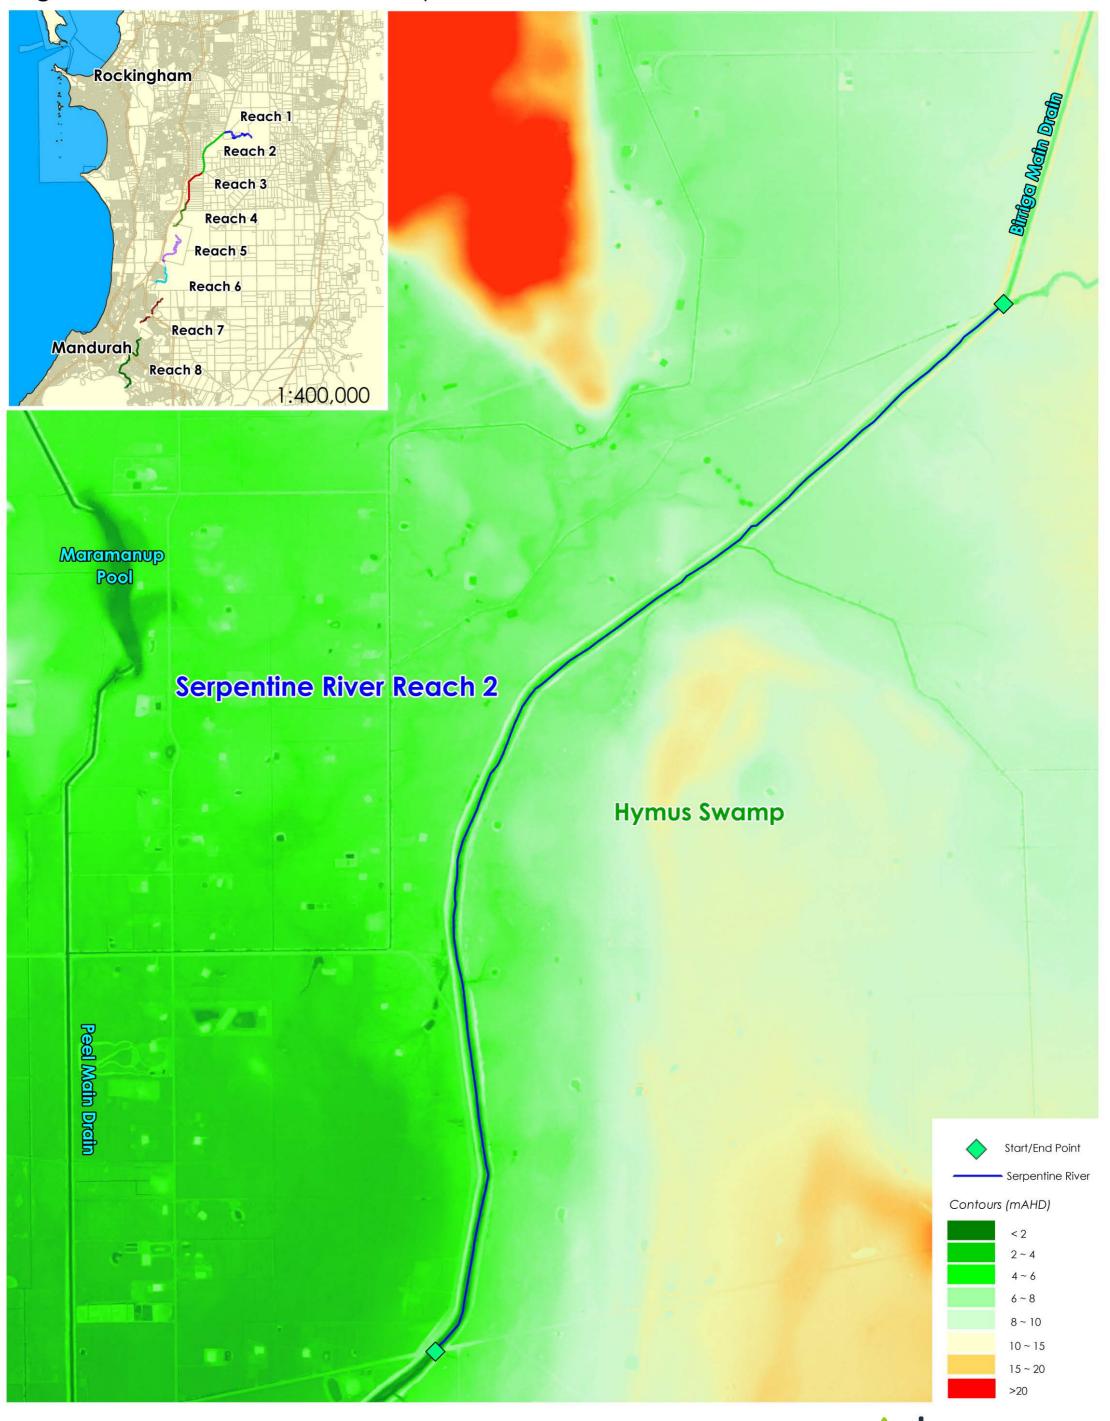
Peel Harvey Catchment Council - Serpentine River Action Plan Figure 9 - Reach 2 Elevation Map

The levee banks are significantly elevated above the surrounding landscape (Figure 9) disconnecting the river from the surrounding wetlands and floodplain, particularly on the western side (SKM, 2009). Despite the constraints of the levee banks, there is variability in the vegetation and habitat condition of the river along the reach. Areas of active erosion were also observed. Most of the reach is fenced, although human and stock access was observed in fenced areas.

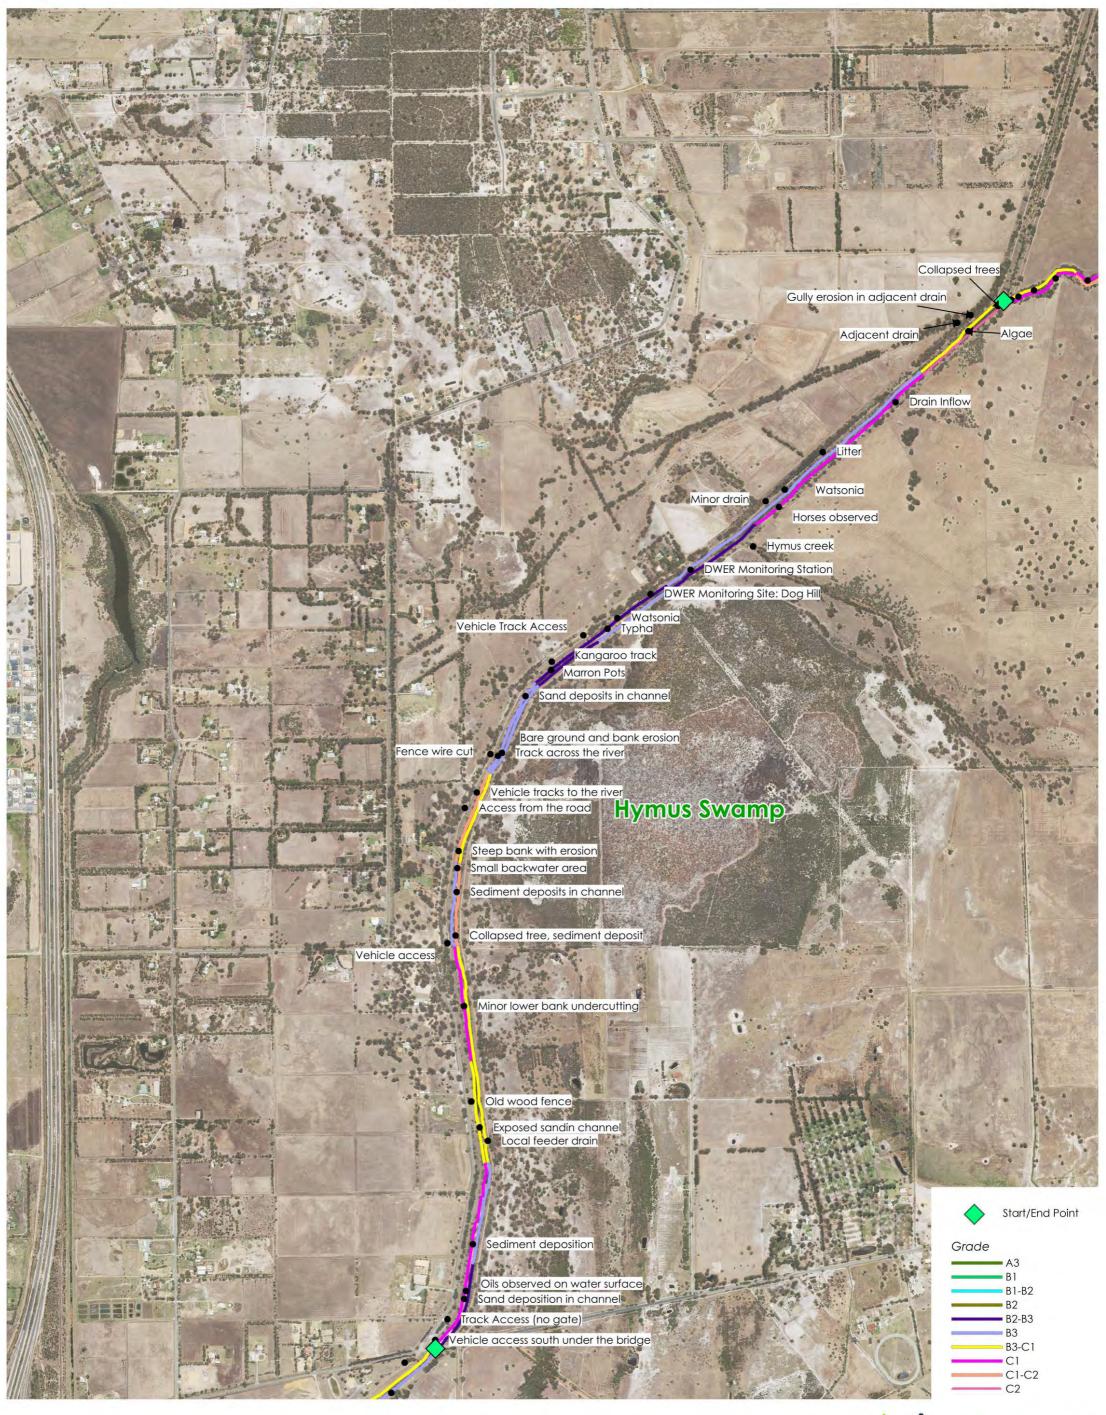
Peel Harvey Catchment Council - Serpentine River Action Plan Figure 10 - Reach 2 Condition Map

Vegetation Cover and Stream Health	Riparian vegetation throughout Reach 2 is generally poor with scattered tree cover and a discontinuous canopy. The trees present are flooded gums and paperbark trees. There are considerable areas of bare ground on the levee banks and the majority of the reach features <50% understorey cover, indicative of the limited riparian vegetation. Rushes and sedges were prominent along the edge of the lower channel. A high proportion of the riparian vegetation present is invasive. Downstream of the DWER monitoring station a dense area of typha was noted in the main channel.
Weeds	The dominant weed species in this reach was watsonia, which was observed in most of the sub-reaches and in large clusters on the levee banks. Invasive ground covers identified in the field included kikuyu, couch grass and love grass. Other common weed species identified in this reach were wild oats, cotton bush, arum lily, lupin and veldt grass. Pig melon was observed in the downstream portions of the reach near Karnup Road.

Erosion	Bank stability varies within the reach as the lower channel is susceptible to erosion from flows, while the wider, higher levee banks are stable. The lower channel contains mobile sediment (potentially builders' sand) that is migrating through the reach downstream and large flow events can cause the lower channel form to be altered. Undercutting of the large banks and tree collapse into the channel were observed in the upstream sub-reaches.
River Health Assessment	The preliminary results of the River Health Assessment (Centre for Sustainable Aquatic Ecosystems, 2020) indicated fish totals are less than in Reach 1, with a significant difference based on the location. Upstream areas near the Birrega Main Drain confluence featured very few fish (18), whereas near the Dog Hill gauging station fish numbers (116) and diversity of species was higher (4 of 5 species). This is attributed to the improved habitat diversity behind the gauging station.

- Improve fencing, particularly at the downstream end, to restrict vehicle access to Reach 2 and under the Karnup Road bridge to Reach 3. Regular
 inspection and maintenance of this fence is required as cutting was noted;

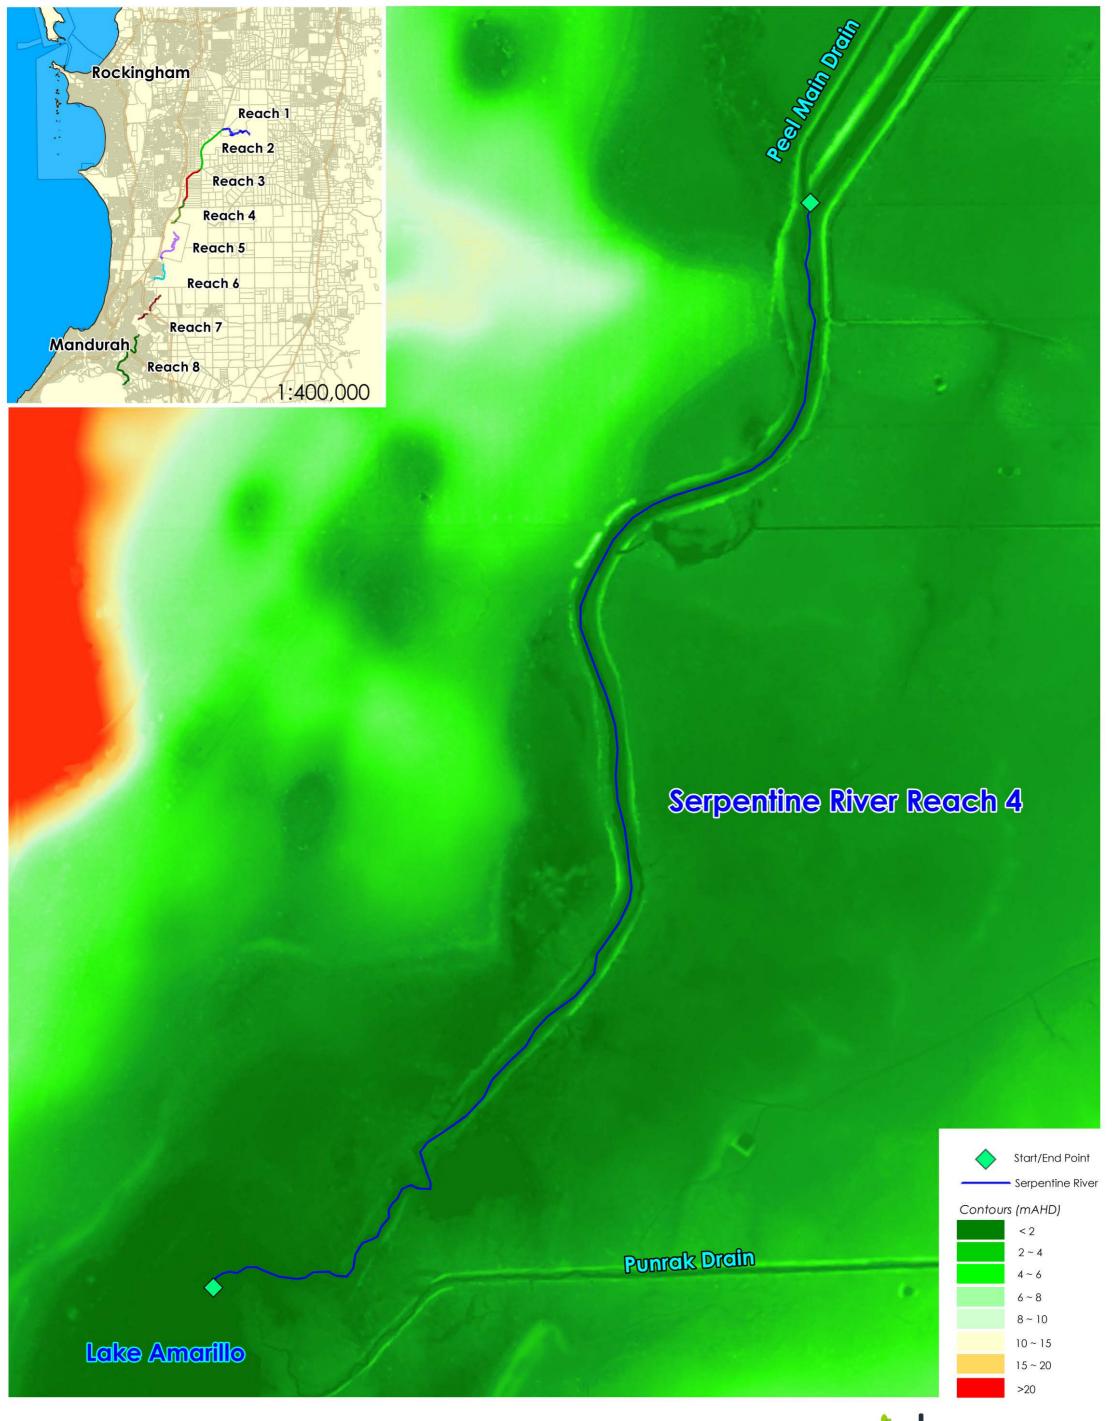
Peel Harvey Catchment Council - Serpentine River Action Plan Figure 15 - Reach 4 Elevation Map

Channel Form The channel transitions from a wide, controlled channel with artificial banks to a narrow, meandering system with ill-defined Amarillo. The levee banks can be seen clearly in Figure 15, along with the increased connection with the floodplain. Within the there is a smaller low-flow channel that is up to 25 m wide with a lower bench to the levee banks. Towards Lake Amarillo the is around 5 m wide. A large rural drain flows into river at the upstream end (with a one-way flap at the outfall).				
General Foreshore Condition Scoring of the channel conditions improved downstream, with the upstream sub-reaches ranging from B2-B3 (degraded and we owing to the improved riparian and verge vegetation. Habitat diversity was consistently low for all sub-reaches given the relow-flow channel, a lack of woody debris and limited backwater areas.				
Vegetation Cover and Stream Health	The vegetation cover is significantly improved in comparison with Reach 3 however riparian vegetation is considerably reduced, particularly the ground and shrub layers. Tree cover was recorded as >50% on the eastern bank, between 10-49% on the western bank, with most trees <10 m (flooded gums and paperbark). Red water fern (native) extends across the entire low-flow channel in areas in some areas. Several dead trees were found near Lake Amarillo. DWER noted estuarine fish species near the confluence with Peel Main Drain.

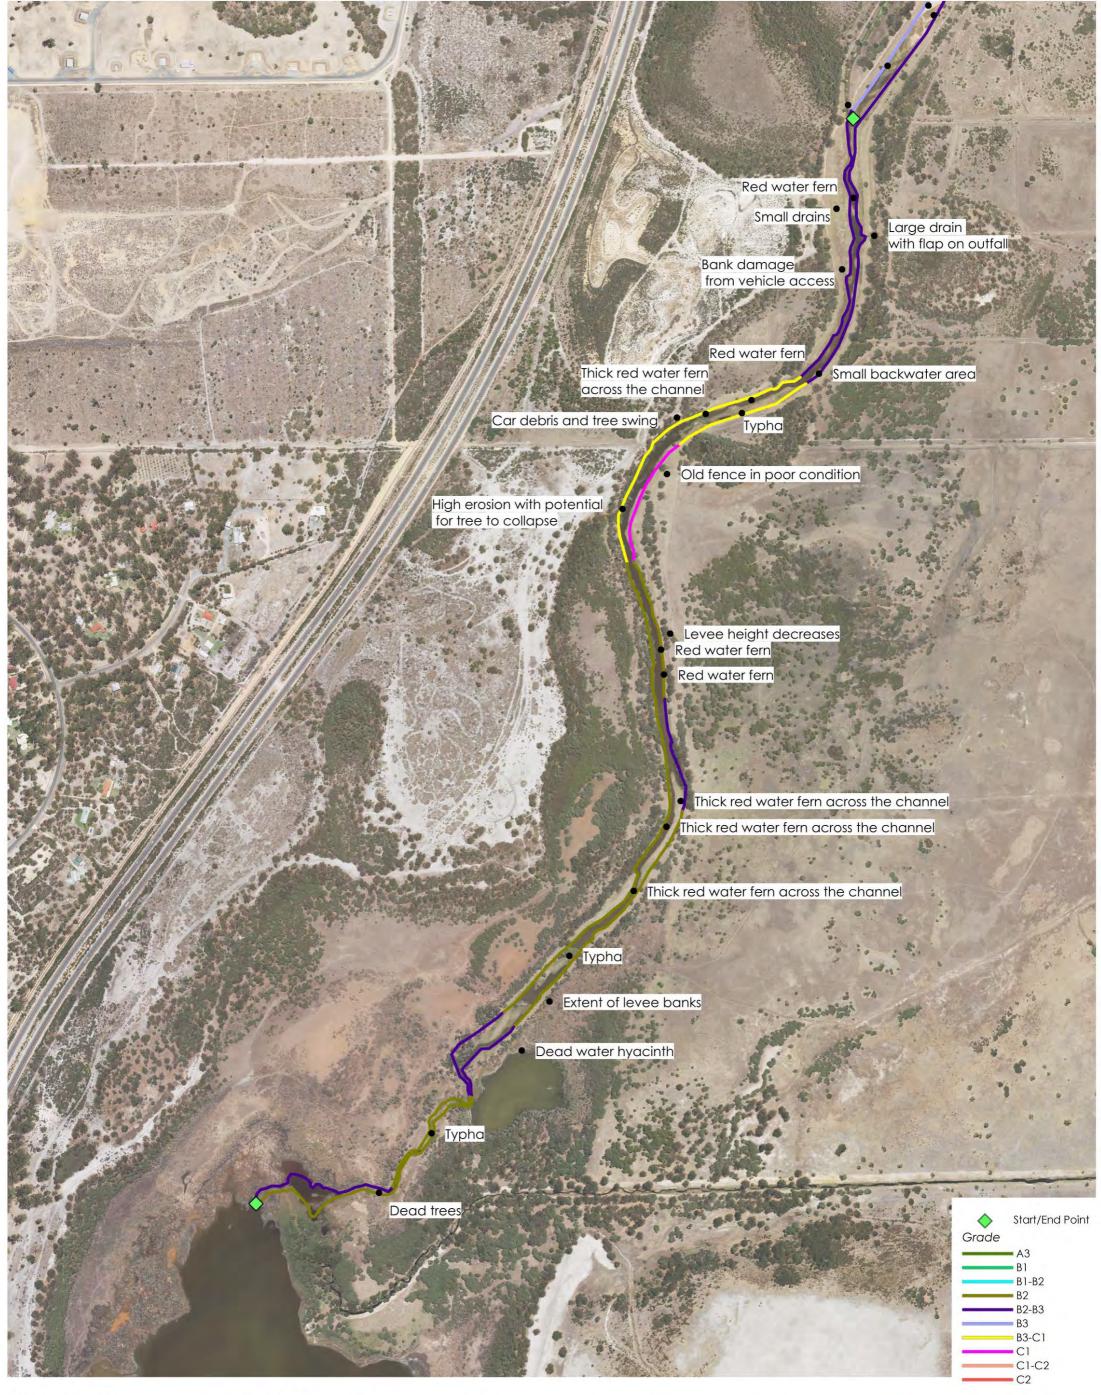
Peel Harvey Catchment Council - Serpentine River Action Plan Figure 16 - Reach 4 Condition Map

Weeds	Several portions of the Reach were clogged by the presence of typha that have grown across the channel (Figure 16). Dead water hyacinth was observed with the small wetland and sub-reaches downstream near Lake Amarillo. Kikuyu and couch grass were noted, though less than in Reach 3. Other weeds identified during the field investigation include arum lily, goosefoot, veldt grass and cottonbush.			
Erosion	The low-flow channel features deposited sediment that creates bars, islands and small backwater areas, similar to Reach 3. Erosion in Reach 4 is generally minor, with limited examples of bank undercutting beneath trees. On both banks there is a further risk of erosion associated with vehicle access, particularly from tracks that are near the low-flow channel.			
Other Issues	Punrak Drain runs perpendicular to the Serpentine River and discharges into Lake Amarillo. The Punrak catchment and water quality impacts are discussed further in Reach 5. Lake Amarillo features seasonal variation in salinity from fresh (winter) to brackish to hypersaline (summer).

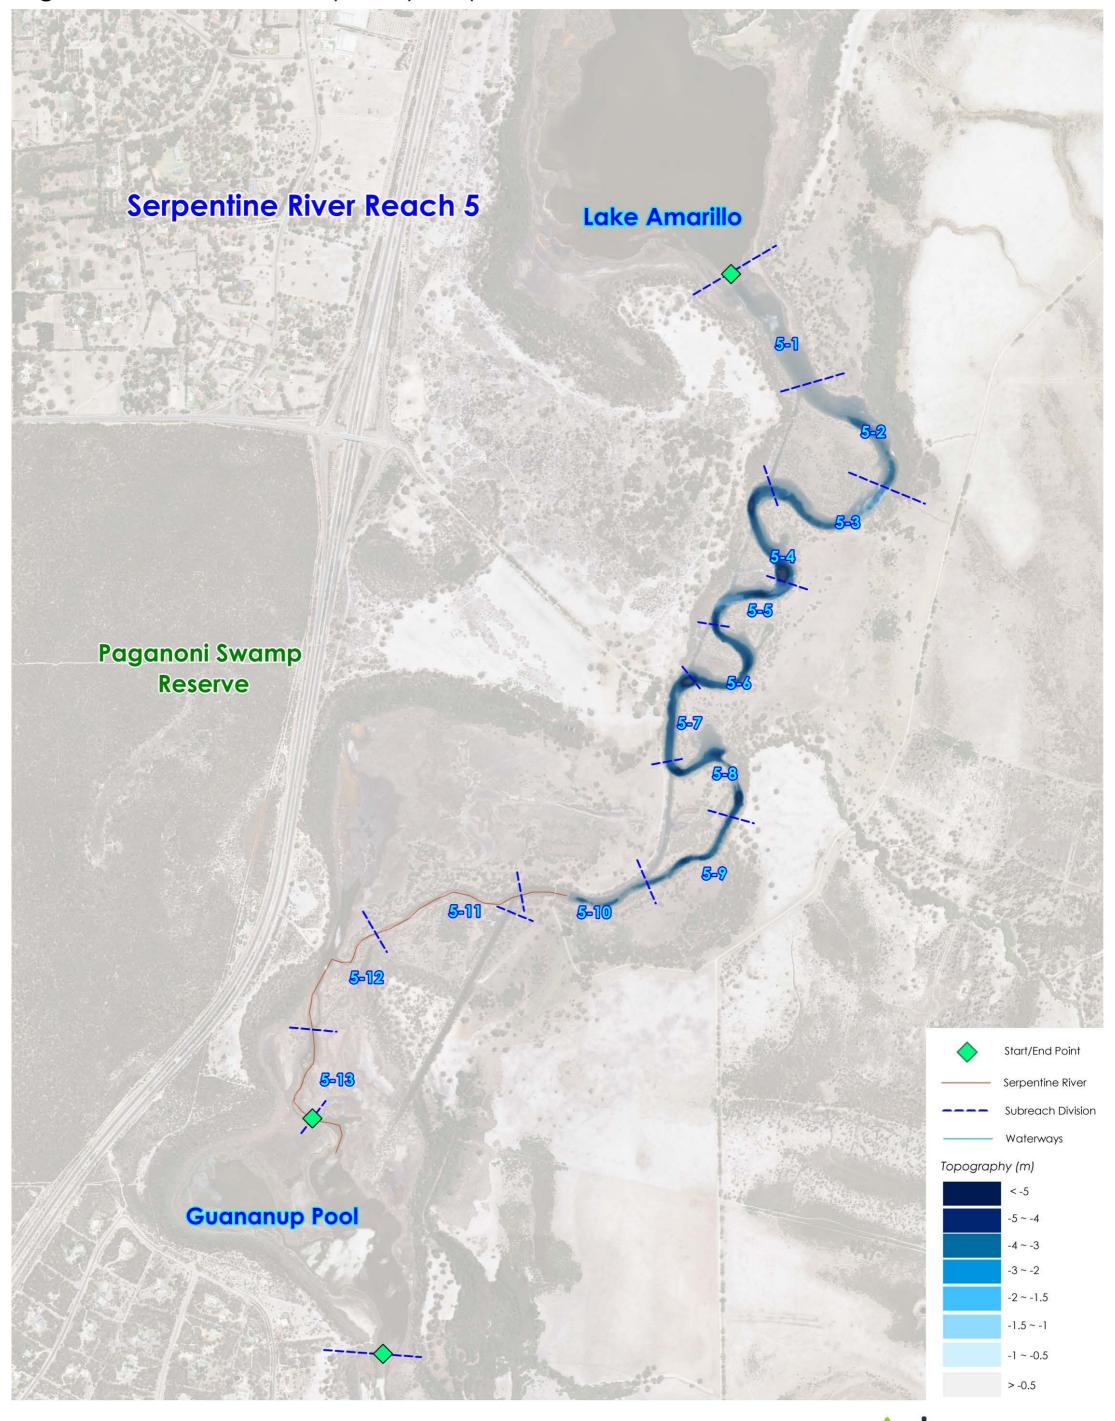
Peel Harvey Catchment Council - Serpentine River Action Plan Figure 19 - Reach 5 Bathymetry Map

The channel form varies considerably from upstream reaches, with an approximately 30 m wide channel featuring a number of 3-4 m deep pools (Figure 19). There are examples of remnant vegetation along this reach in better condition that elsewhere, in particular in the large flooded gums on the eastern bank. The river and western floodplain are classified as Conservation Category Wetlands, whilst the eastern floodplain is classified as Multiple Use. Both floodplains and the river are within the Bush Forever (Site 394) area. Guananup Pool is a tidal flat with numerous dying trees.
