# Lower Murray River Action Plan

REVIEWED AND UPDATED 2014

Original document produced by the Department of Environment 2003 Updated by the Peel-Harvey Catchment Council 2014

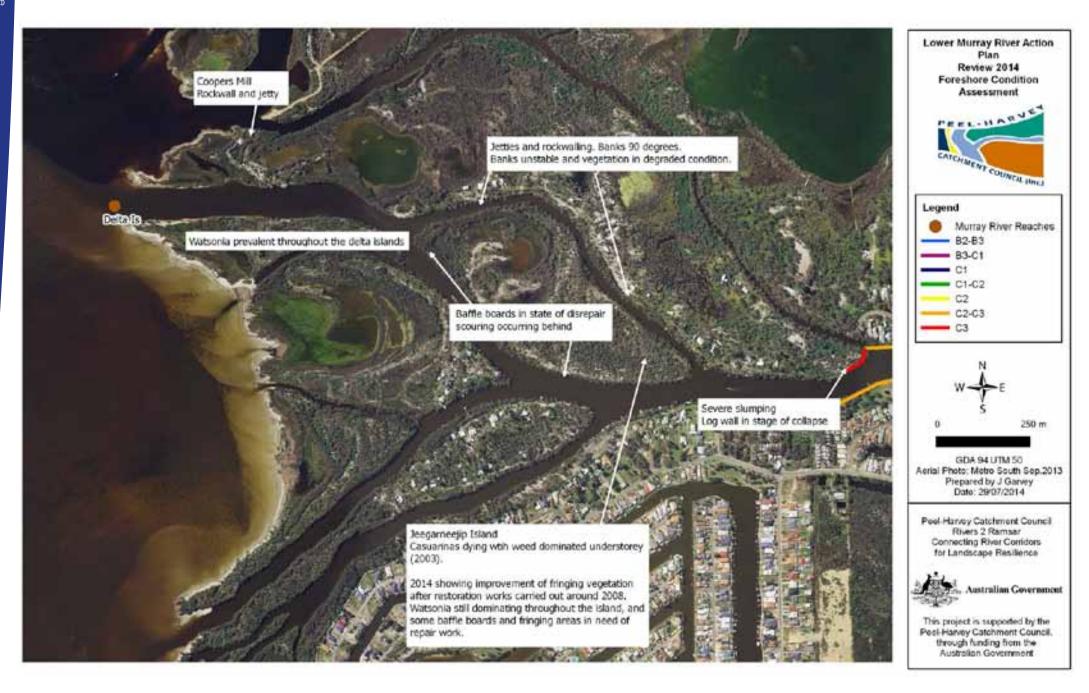
Reach 1- Murray River Delta Islands - Foreshore Condition Assessment Map 2014

CONDITION	
Feature	Comments
Vegetation	Delta Islands support shallow rooted, salt tolerant vegetation such as Samphire, Paperbark and Casuarina. Some sedges and rushes line the river foreshore. There is evidence of Samphire regeneration in lower areas under tidal influence. Demise of Melaleuca, Eucalypts and Casuarina along delta tidal flats has been influenced by increased tides.  East of the Delta Islands the overstorey is predominantly Paperbark (Melaleuca spp) and Casuarina. The understorey is very sparse with isolated clumps of sedges and rushes where rock or log walls are absent. The local community has undertaken some revegetation of the reserves. There has been a loss of fringing vegetation along all urban areas and foreshore reserves.
Weeds	Watsonia and love grass dominate large areas of the understorey. Exotic garden weeds are also present (mostly situated near/on housing). Typha patch located at Clansman

Bank Stability & Erosion	Banks are generally stable due to extensive rock and log walling. However, increased tidal activity from the Dawesville Channel has caused clay banks to slump and some older areas of walling are degrading. Increasing human activity has resulted in the loss of sedges, rushes and upperstorey vegetation and an increase in foreshore erosion. Baffle boards have been placed at points along this section. Most have failed to stop erosion and add to the stability of the reach. Deposition is evident between Cooleenup and Jeengarnyeejip Islands.
Habitat	The Delta Islands provide a variety of foreshore habitats for terrestrial animals including roosting sites. Instream habitat is varied as the braided channel provides a variety of widths and depths, as does the tidal influence. There is a significant amount of instream woody debris. East of the Delta Islands the reach is straight. Some instream woody debris exists along the water-edge providing roosting sites but rock and log walls have replaced much of the natural embankment. Foreshore habitat is sparse due to the removal of vegetation.

Other Comments	Unauthorised access by small boats is resulting in the destruction of fringing vegetation and erosion. Increased tidal activity since the construction of the Dawesville Channel, impacts of storm surges and flooding has led to a loss of vegetation along this reach. Illegal activity was evident at certain points along the reach, such as illegal clearing of vegetation and new jetty construction.  Where baffle boards have been installed along this reach in the past appeared to have failed to improve bank stabilisation.

- 9. Provide walk and cycle paths to minimise human impact along foreshore reserves.
- 10. Produce and implement a weed management plan for all reserves and Delta Islands, focusing on areas that can be effectively managed.
- 11. Introduce poo bags and erect signage to ensure all dogs are restrained on a leash in foreshore reserves to protect riparian vegetation and reduce excrement fouling public reserves and entering the river.
- 12. Monitor and review recreational facilities and impacts along reserves.
- 13. Include drainage mapping to identify point source pollution and possible streamlining, retrofitting, etc activities.
- 14. Identify and sign historical landmarks.
- 15. Form working groups to assist in maintaining foreshore areas
- 16. Engage community to assist with local councils to implement management plans

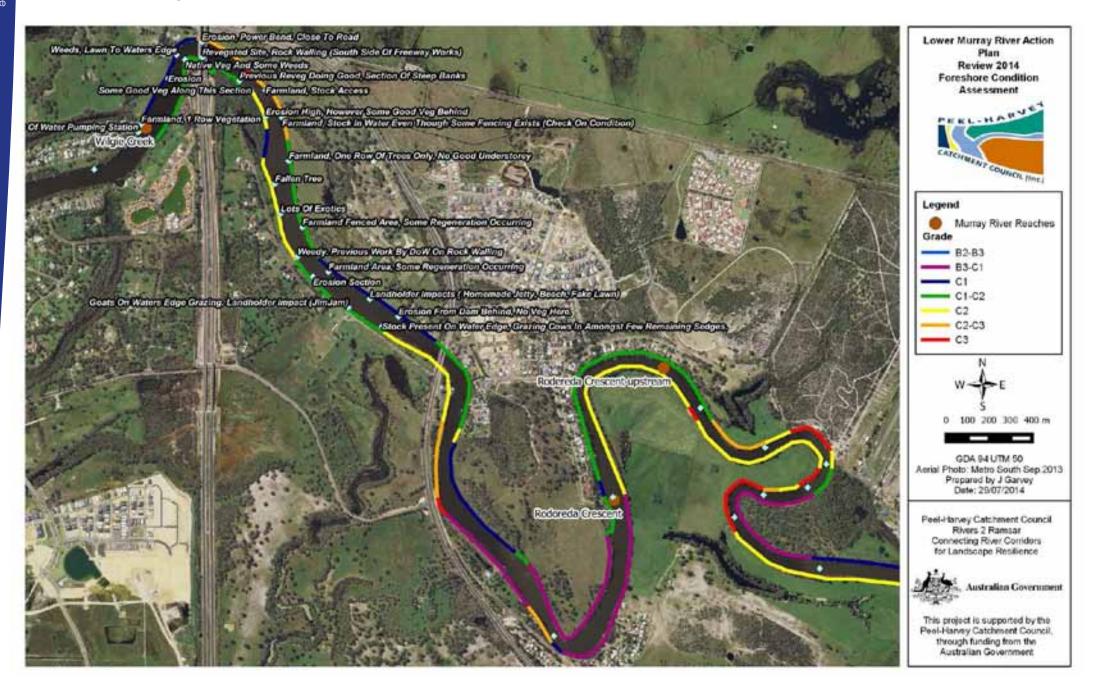
Reach 2 - Wilgie Creek to Rodoreda Crescent - Foreshore Condition Assessment Map

Other	Crown reserves 26526 and 34502 are zoned for 'public recreation' but are unvested.
Comments	Reserve 26526 appears to be currently used for grazing and adjoins Lot 63. The 2014 survey revealed these sections as potential revegetation sites.
	Perth to Mandurah Freeway is now completed and has since lowered in condition rating for the right bank. There is no wall or stabilisation on the left hand bank.
	There were signs of stock impacts on shoreline between sedges at Lot 12 on day of survey (2014). Stock were present. The condition rating for this section of the reach shows further degradation.
	The right bank from bridge, heading east has also degraded more over approximately 500 metres.

- 10. Provide walk, bike and horse trails to reduce human and animal impact on foreshore reserves.
- 11. Introduce poo bags and erect signage to ensure all dogs are restrained on a leash in foreshore reserves to protect riparian vegetation and reduce excrement fouling public reserves and entering the river
- 12. Monitor and review recreational activities along foreshore reserves.
- 13. Produce and implement a long term maintenance plan to control weeds and minimise fire risk.
- 14. Identify and sign historical landmarks.
- 15. Look at potential revegetation/bank stabilisation projects along this reach.

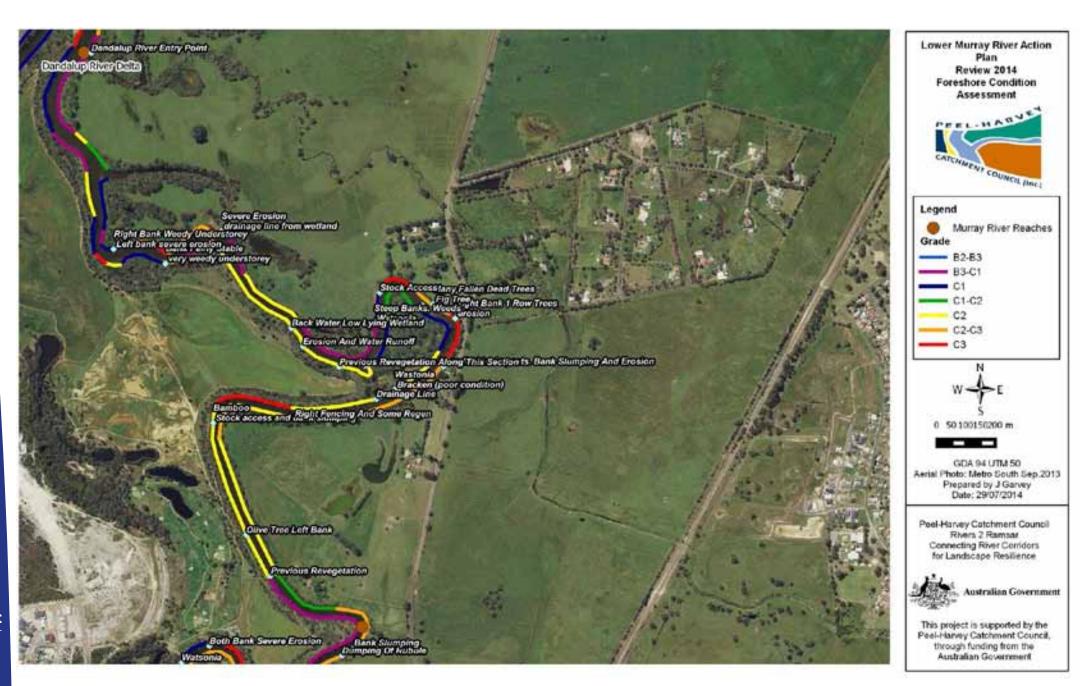
Reach 5 - Dandalup River Inlet to 5km-bend - Condition Description Map

This reach is approximately 4.4 km long and includes a backwater, and numerous meanders and bends. The left bank vested is with the Shire of Murray as part of the Ravenswood Sanctuary Development (now called 'Murray River Country Estate'), and has been successfully revegetated with an improvement in condition compared to 2003. Most of the area is fenced from stock, however one section remains unfenced in the upstream section near 5km bend. The right bank is still grazed.

- 9. Introduce additional boat signage to create awareness of impacts to foreshore
- 10. Produce and implement a long term maintenance plan to control weeds and minimise fire risk.
- 11. Identify and sign historical landmarks.

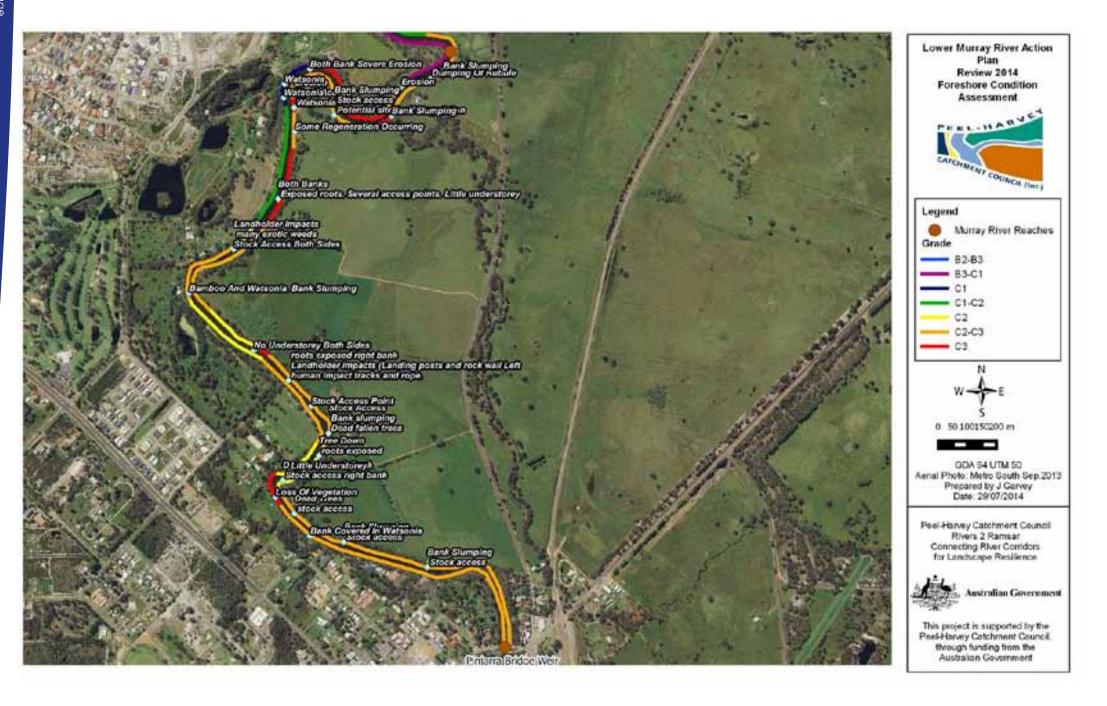
Reach 6 - 5km-bend to Pinjarra Townsite Weir- Condition Description Map

DESCRIPTION						
Landuse	Rural grazing land dominates the right bank, with urban blocks located close to the Pinjarra Bridge. There is evidence of stock access to the river along this reach. The lank consists of semi urban and urban blocks with a few small reserves, vested with the Shire of Murray.					
Fencing	There is little to no fencing on either side of the river. An isolated stretch exists on the right bank near the urban blocks.					
Landforms and Soils	P10 soils dominate with some sections of P6a. Near the Pinjarra Townsite small areas of P6b and P1a exist.					
CONDITION						
Feature	Comments					
Vegetation	This reach is highly degraded with a patchy overstorey of swamp paperbark (Melaleuca rhaphiophylla) and flooded gum (Eucalyptus rudis). There is very little to no understorey present and very little natural regeneration. Weeds dominate the understorey.					
Weeds	There is an infestation of weeds along this reach, probably due to the proximity of urban development. Weeds include olive trees, bamboo, watsonia, love grass, arum lily nasturtiums and other domestic garden plants. Pasture grasses are dominant in the rural area along the right and left banks.

Bank Stability & Erosion	Stock access has resulted in severe erosion and bank slumping along the right bank.					
Habitat	This reach is highly degraded with a patchy overstorey of swamp paperbark (Melaleuca rhaphiophylla) and flooded gum (Eucalyptus rudis). There is very little to no under present and very little natural regeneration. Weeds dominate the understorey.					
Other Comments	Stock access is a major contribution to degradation on right bank, and exotic garden weeds dominate left bank.

- 7. Produce and implement a weed eradication and maintenance plan.
- 8. Develop appropriate passive recreational opportunities such as walk trails.
- 9. Introduce additional boat signage to reduce wake erosion.
- 10. Identify and sign historical landmarks.
