Mayfield Drain

Mayfield Drain catchment drains west from the Darling Plateau, discharging into the southern end of the Harvey Estuary. The catchment has 237 km of natural and modified waterways of which approximately half are gazetted under the Waroona Drainage District and managed by the Water Corporation.

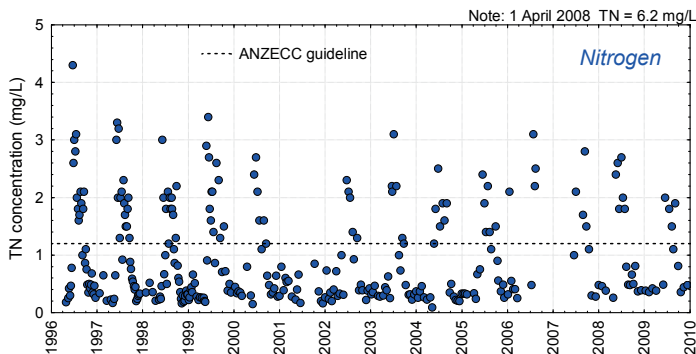
Total nitrogen (TN) and total phosphorus (TP) concentrations (1996–2009)

TN concentration:

The annual percentage of TN samples that exceeded the ANZECC¹ guideline for lowland rivers (1.2 mg/L) ranged between 0% in 2001 and 50% in 2007.

Between 1996 and 2004, 30% of samples exceeded the guideline. This value increased to 35% for the period between 2005 and 2009.

TN trend:

Trend analysis was undertaken using data from 2005 to 2009 inclusive.

Once the data were adjusted for flow and seasonality, an emerging increasing trend (0.13 mg/L/year) was detected.

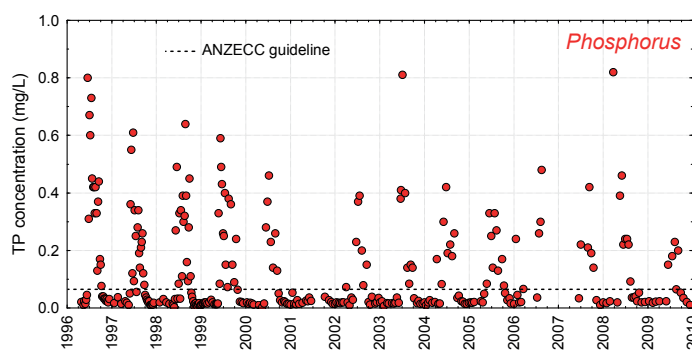
TP concentration:

The annual percentage of TP samples that exceeded the ANZECC¹ guideline for lowland rivers (0.065 mg/L) ranged between 0% in 2001 and 63% in 2007.

Between 1996 and 2004, 39% of samples exceeded the guideline. This value increased to 44% for the period between 2005 and 2009.

TP trend:

Trend analysis was undertaken using data from 2005 to 2009 inclusive.

Once the data were adjusted for flow and seasonality, an emerging increasing trend (0.014 mg/L/year) was detected.

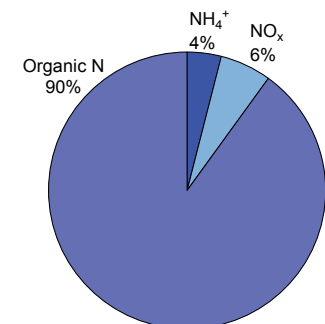
Nutrient fractions (2005–09)

Nitrogen:

Most of the nitrogen (N) present was organic in nature. Organic N consists of both dissolved organic and particulate nitrogen. It is derived from degrading plant and animal matter and fertilisers. It often needs to be further broken down before it can be used by plants and algae.

The remaining N was dissolved inorganic N (DIN) such as ammonium (NH_4^+) and N oxides (NO_x).

DIN is also derived from animal wastes and fertilisers but is readily available to plants and algae.

Mayfield Drain had the second-lowest percentage of DIN of the catchments draining to the Harvey Estuary (10%). It was one of five sites within the Peel-Harvey catchment where 90% or more of the N present was organic.

Approximately two-thirds of the phosphorus (P) was present as particulate P, which consists of sediment-bound forms of P and organic waste materials.

The remaining P was present as soluble reactive phosphorus (SRP), which is derived from fertilisers and animal wastes. SRP is readily available for uptake by plants and algae.

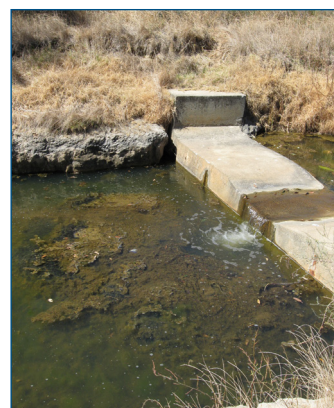
Macroalgae - March 2009

Excessive algal growth and in-stream vegetation suggests that nutrient reduction strategies are required.
