Hotham-Williams River Action Plan

Prepared for
Peel-Harvey Catchment Council

By **Urbaqua**

May 2020

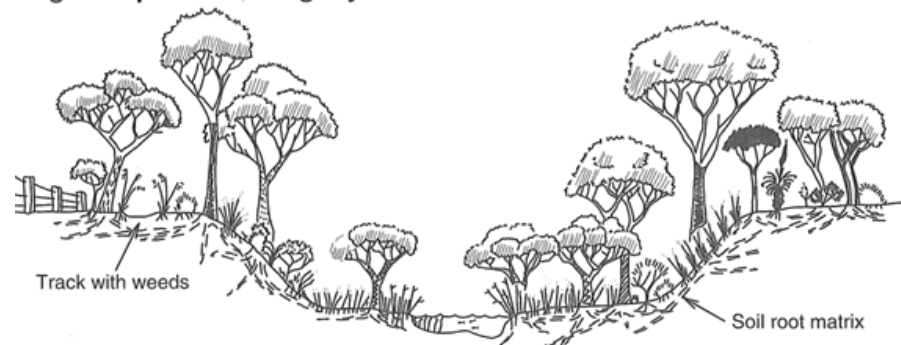
Figure 3: Pen-Scott Foreshore Condition Assessment (Pen & Scott, 1995)

A grade: pristine to slightly disturbed

B grade: degraded

C grade: erosion prone to eroded

D grade: ditch

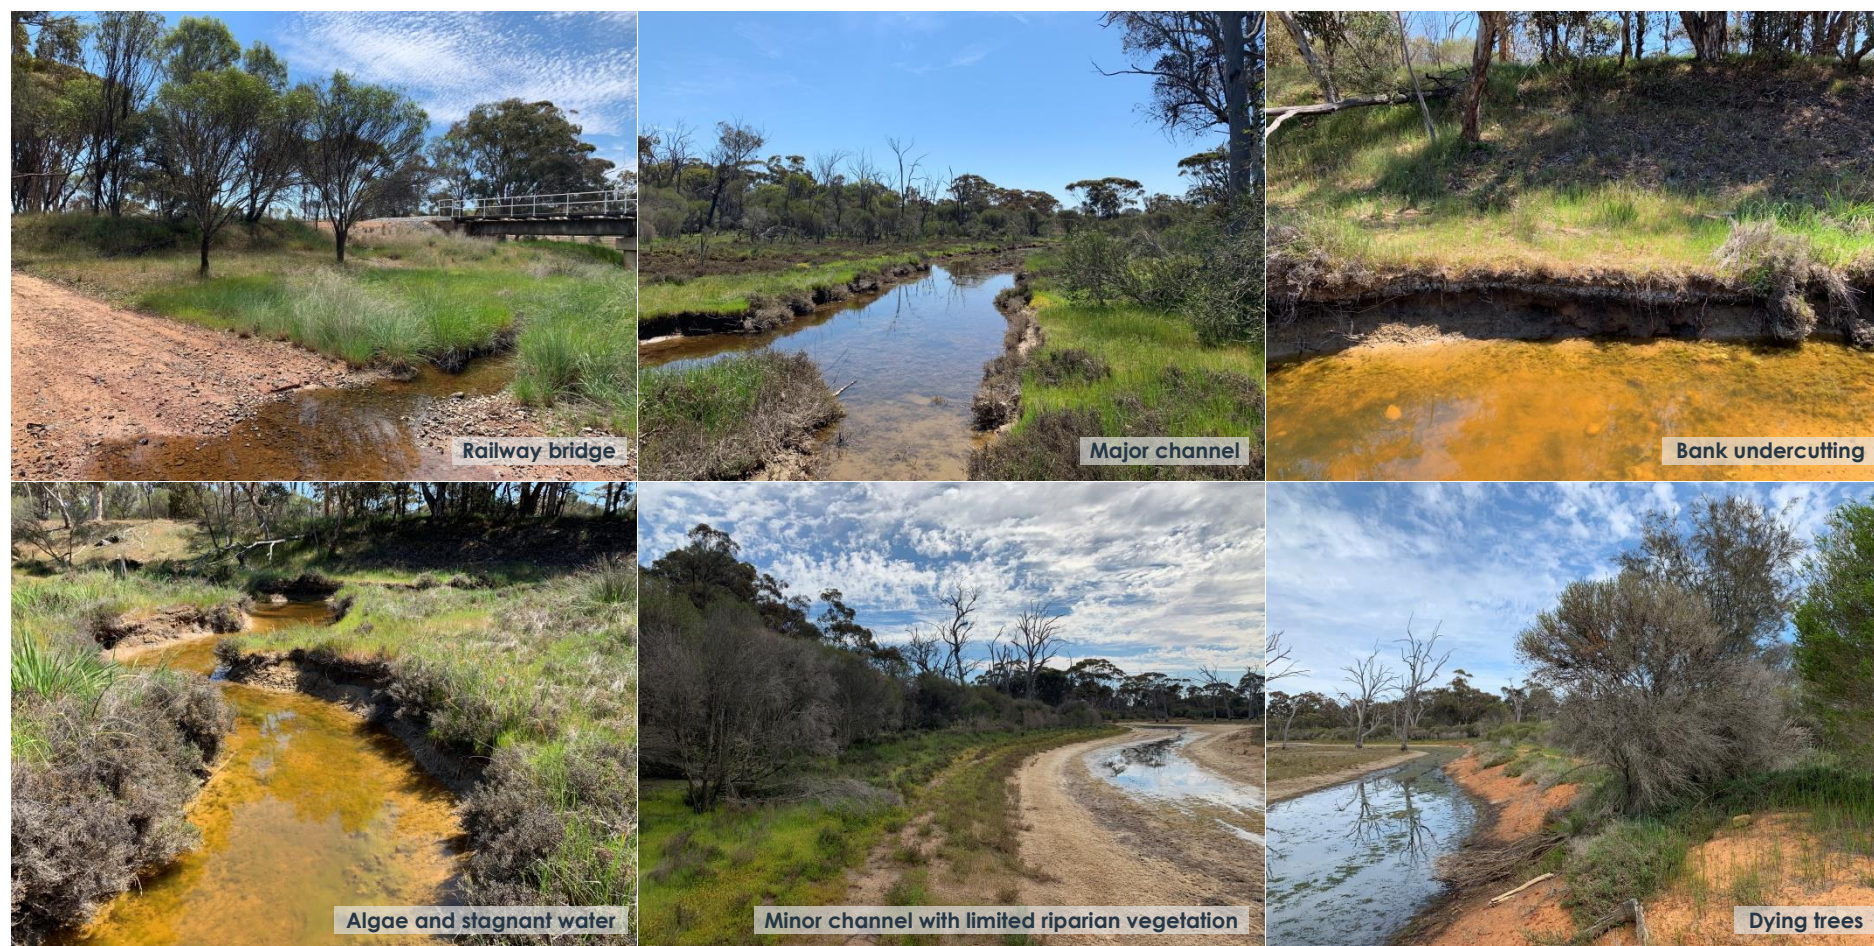
The Yornaning Dam reach includes two creeks that flow into the Dam, covering a total distance of 1.2 km as shown in Figure 5. Assessment of this reach included the definition of 6 sub-reaches, each being approximately 200 m in length. Characteristics of the creeks at this site, defined by results of the field assessment and desktop review are provided in Table 9, with management recommendations provided in Table 10.

Feature	Comments
Land use	The dam and assessed reaches are within areas of remnant vegetation that are part of the Yornaning Dam Reserve. There is rural land south and north-east of the reserve, along with the CBH facilities near the railway line.
Fencing and Infrastructure	The dam is used for recreation by the community and there are vehicle tracks throughout the site including one crossing near the railway bridge (upstream end of the assessed reaches). Fencing is largely offset from the channel, either on the boundary of the rural property to the south or along the tracks within the reserve (east of the main channel). Fencing was rated as in good condition, and there was no evidence of stock access, though dog tracks were noted near the minor channel.
Channel Form	There are two channels that flow into the dam, a major channel flowing under the Great Southern Highway and a minor channel that collects drainage from the adjacent rural property, west of the major channel (Figure 5). The major channel is relatively narrow (2-3 m) and features a meandering profile and shallow banks. The minor channel is an ephemeral system with no distinguishable banks and has been heavily modified from a natural state.

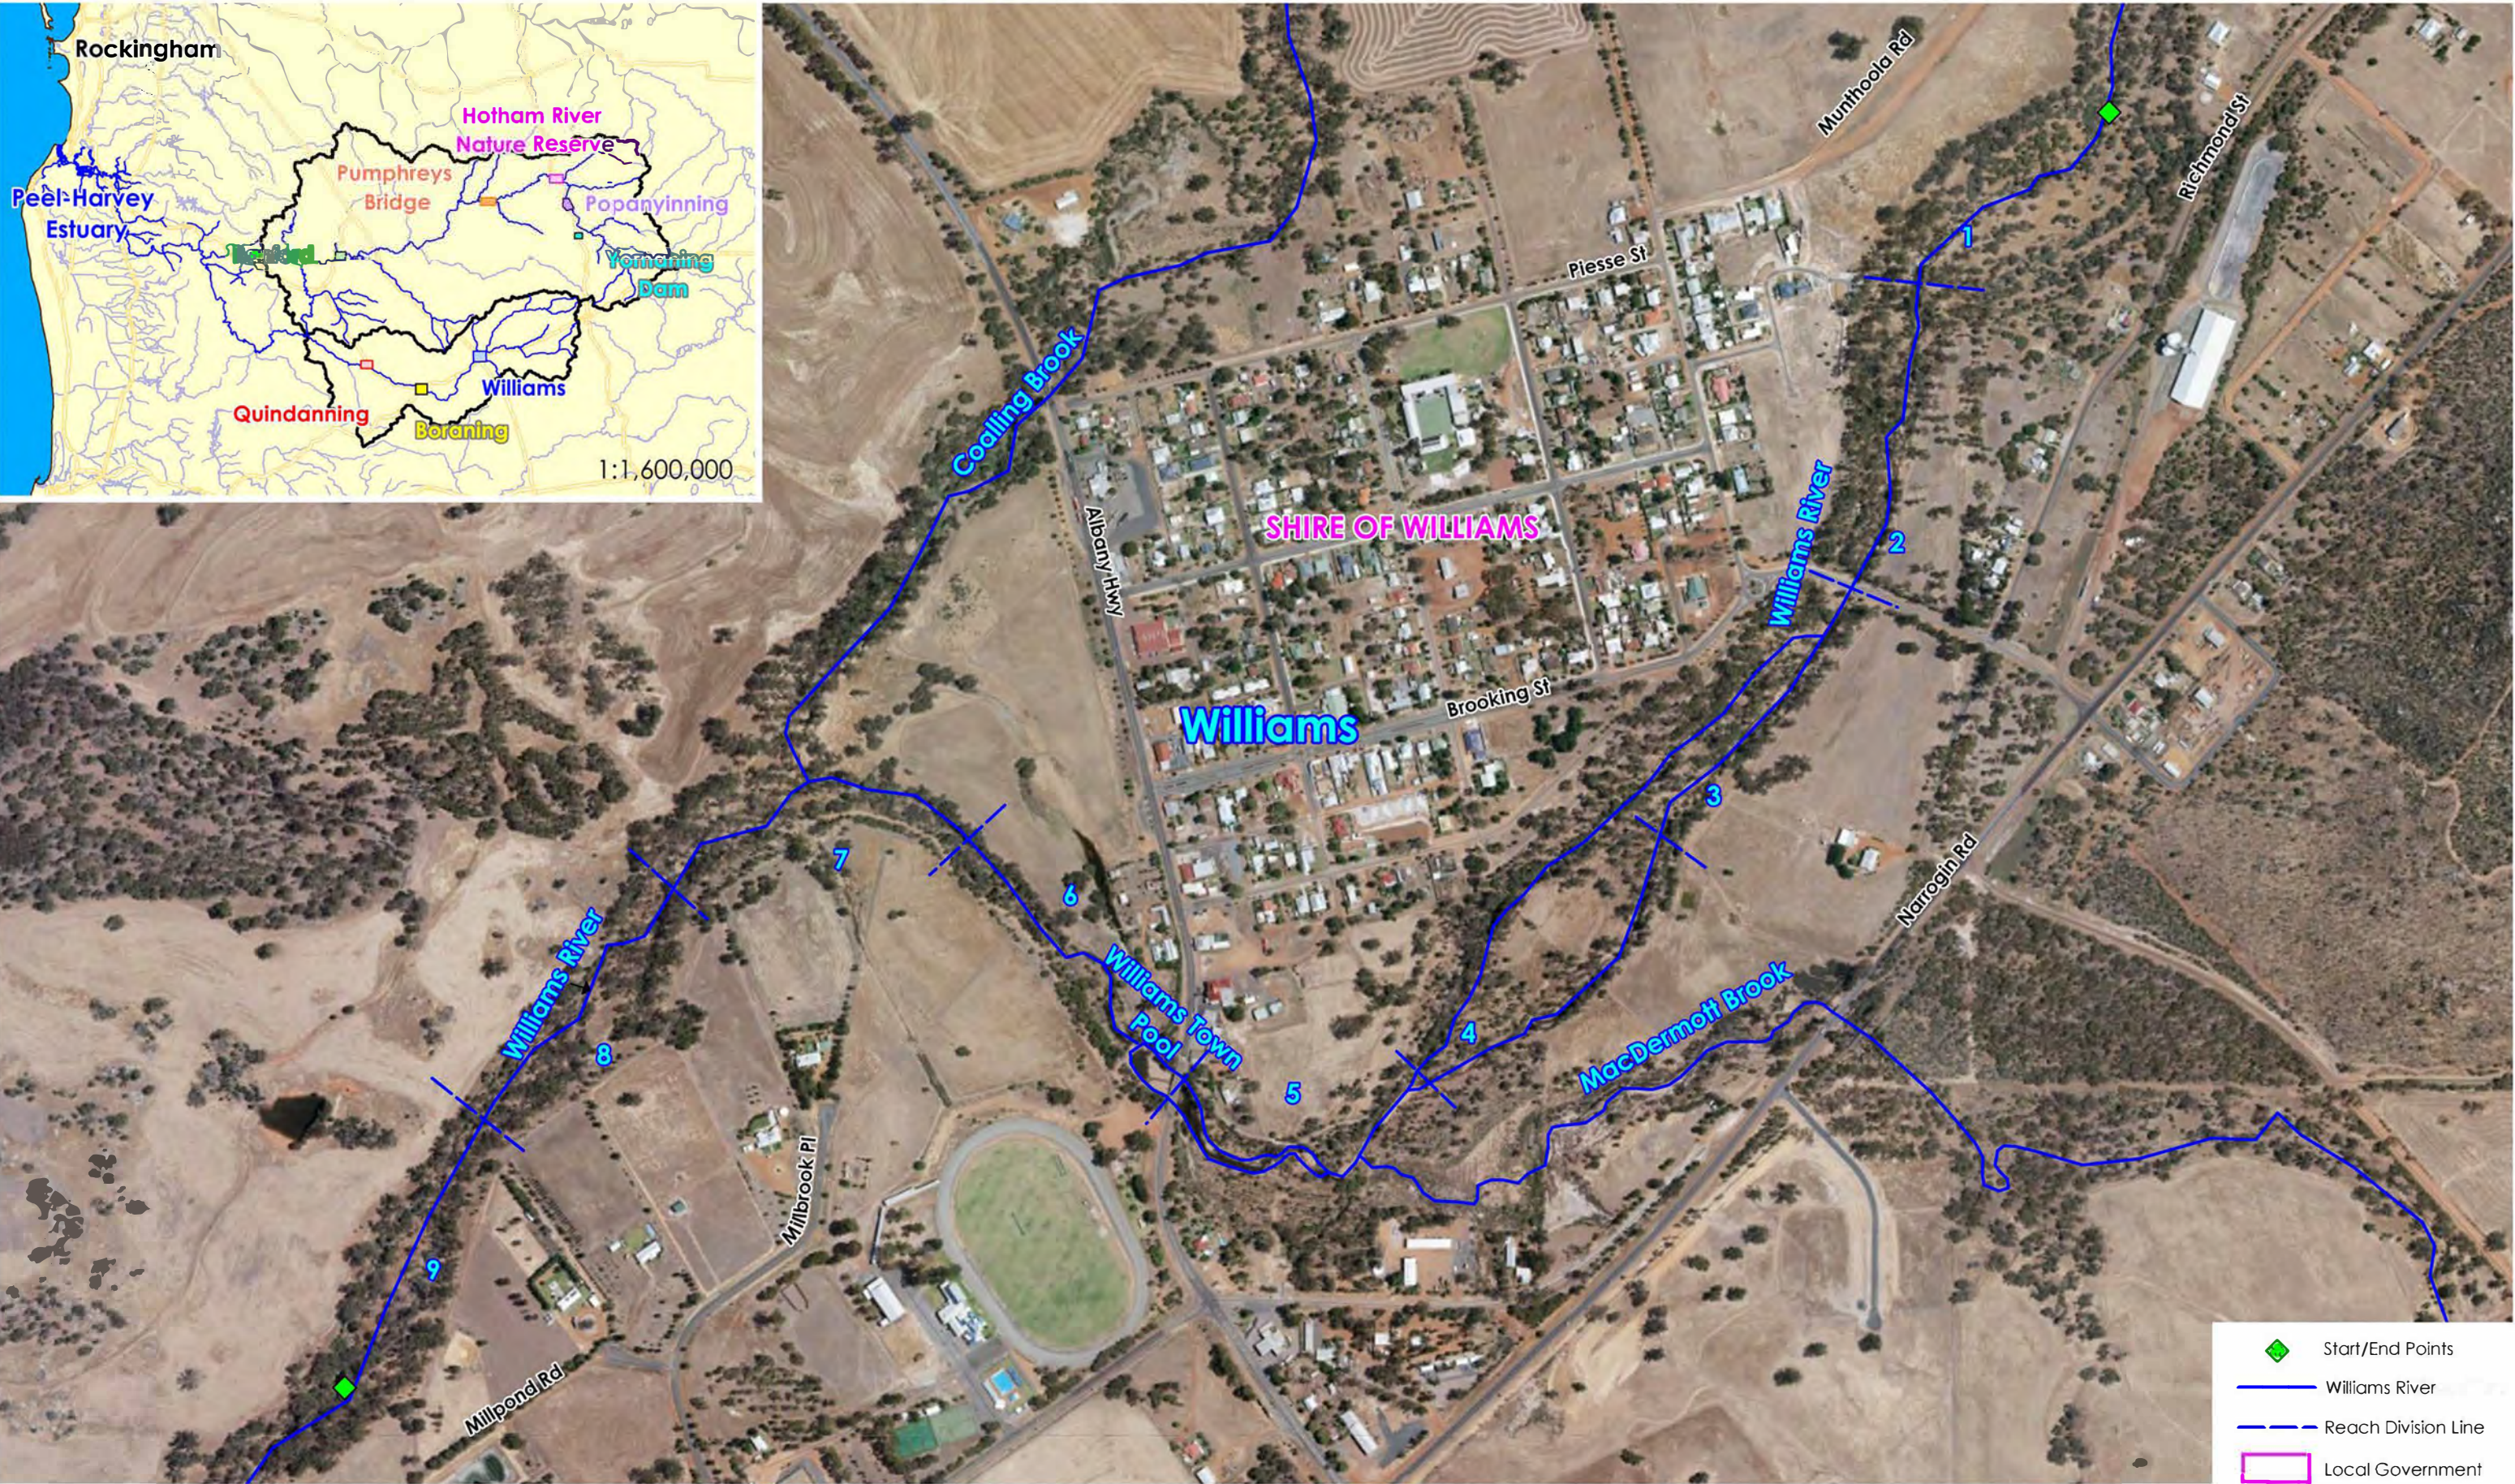
Figure 25 - Williams Location Map

The assessment reach of the Williams River with the Williams townsite extends upstream and downstream of Albany Highway covering approximately 3.4 km. Assessment of this reach included the definition of 9 sub-reaches, each being approximately 400 m in length (Figure 25). Characteristics of the river, defined by results of the field assessment and desktop review are provided in Table 19, with management recommendations provided in Table 20.

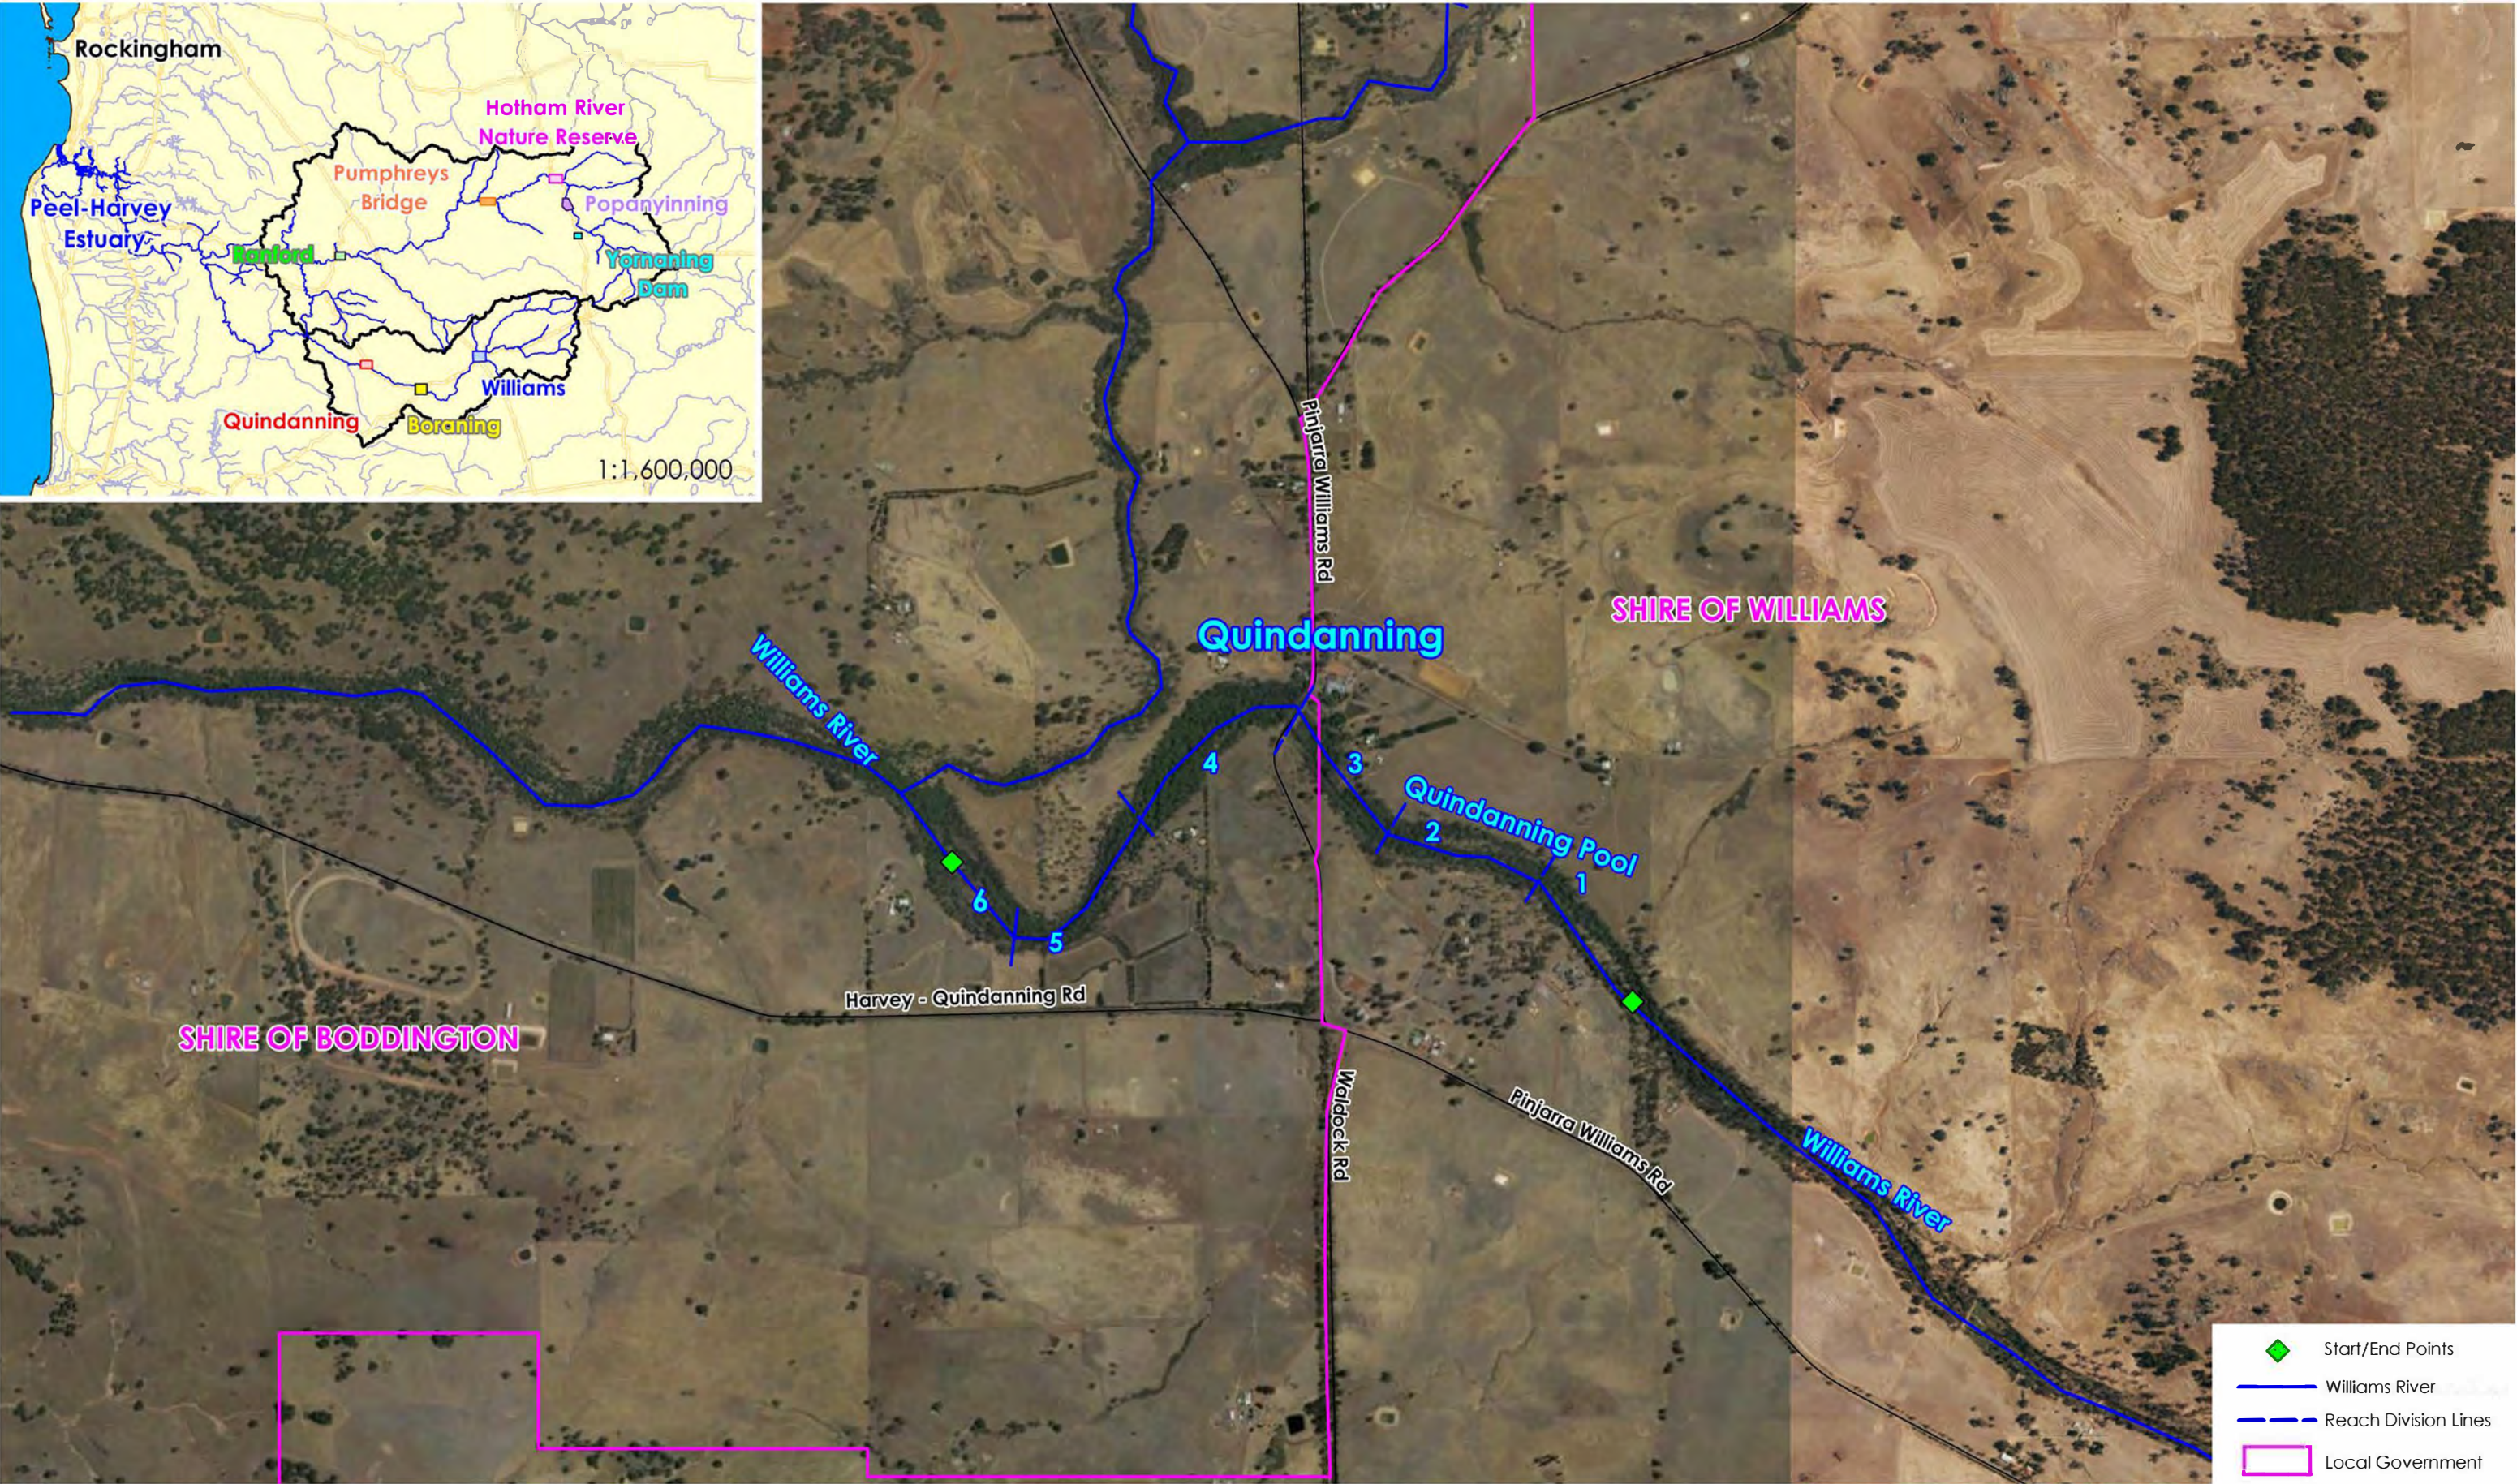
Figure 33 - Quindanning Location Map

The Quindanning reach of the Williams River is south of the Quindanning townsite, covering approximately 2.3 km upstream and downstream of the Pinjarra-Williams Road Bridge as shown in Figure 33. Assessment of this reach included the definition of 6 sub-reaches, each being approximately 400 m in length. Characteristics of the River, defined by results of the field assessment and desktop review are provided in Table 23, with management recommendations provided in Table 24.
