Hotham-Williams River Action Plan

Popanyinning Detailed site plan

Prepared for
Peel-Harvey Catchment Council

June 2022

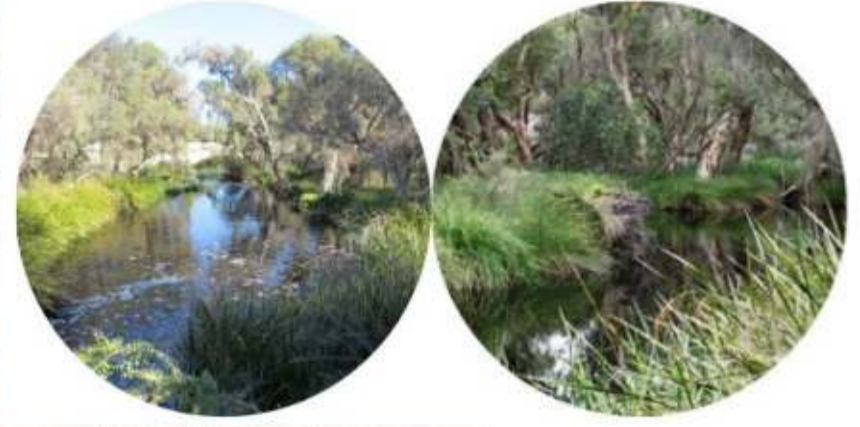
Revegetation examples:

- Revegetation**
- Comprehensive restoration of 30m riparian buffer zone
 - Spot removal/replacement of weeds and problem exotics
- Bank stability**
- Mix of rock revetment and woody debris (where required)
 - Woody debris (where required)
 - Cross section locations (refer to cross section plan)
- Access**
- Proposed pedestrian access track
 - Existing pedestrian access track
 - Improved crossing
 - New road layout proposed by the Shire/Main Roads
 - Investigate and install fencing as required to control stock access to River
- Amenity**
- Directional signage for wayfinding
 - Historic information & Directional signage for wayfinding
 - General information & Directional signage for wayfinding

Due to the degree of weeds and degradation of native vegetation, a large portion of the site requires comprehensive weed removal and re-establishment of native species in riparian areas, which will provide a buffer to the adjacent land uses. In some instances, spot weed removal will be sufficient to regenerate native grasses that are present at the site. Additional trees are recommended to enhance canopy and biodiversity, and where appropriate, the addition of mid-storey species will assist with long term weed control.

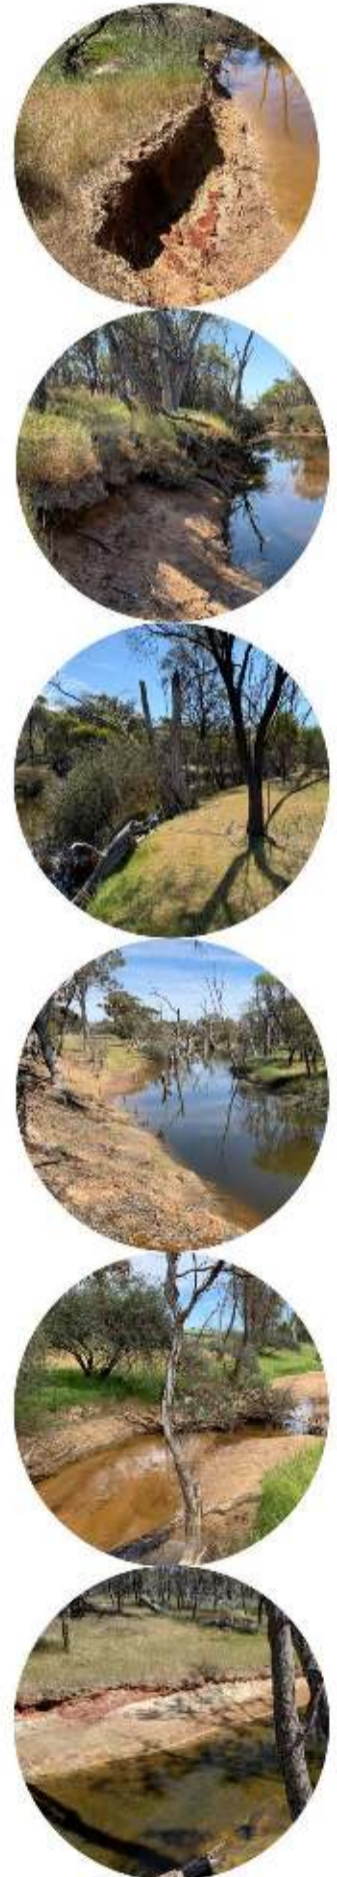
Figure 1: Popanyinning Site Concept - Restoration Plan

Existing conditions:

The recommended works (Figure 1) will address issues caused by informal crossings and stock access, as well as bank stability. Bank and channel interventions include stock control via fencing, controlled stock access points, bank and bed stabilisation with revegetation, and profile modification to reduce velocities.

The proposed works are detailed in Figures 1 and 2 as follows.

- Comprehensive weed removal in degraded areas with spot weed removal and control of exotics in other areas (see Figure 1).
- Bank stabilisation works as indicated in Figure 1. Where banks are modified but unable to achieve a 1:3 grade, some form of matting is likely to be required. This may also be required where the sediment is sandy or otherwise unstable.
- Revegetation of minimum 10m riparian corridor (where permitted by land tenure and land use).
- Cutting back local drain outlet and provision of rocks and vegetation to provide water quality treatment, stabilise the area and reduce erosion.
- Ongoing communication with the Shire of Cuballing throughout the road realignment, so that activities such as revegetation and weed control are complimentary to the process.

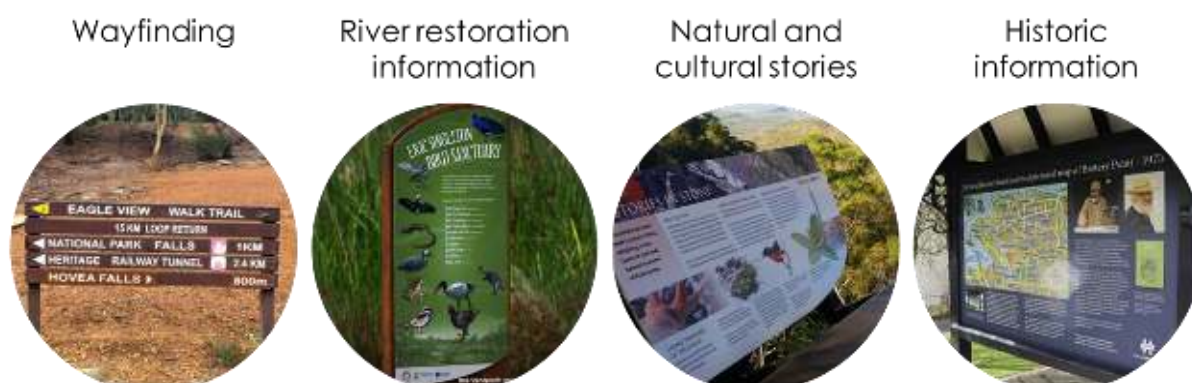
Signage examples

- Creation of a path network that links to the existing path network.
- Information will be displayed to acknowledge Noongar and European history of the River at Popanyinning and communicating its cultural and historical significance, including the way the Noongar people and Europeans have valued this place throughout history (at least 1).
- Signage will also be included to provide information at key entry points to bushland reserves adjacent to the River, which includes information on river restoration (at least 3) and wayfinding (at least 2).
- Construction of the proposed realignment of Bunmulling Rd including a footbridge crossing over the river.
- Improvements to existing crossings (2) including bank stabilisation and culvert modification to reduce damming, overtopping and erosion.
- Planting additional canopy trees in the reserve area.

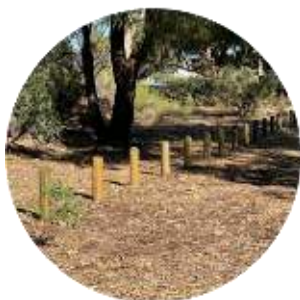
Bollards or large boulders for vehicle access control

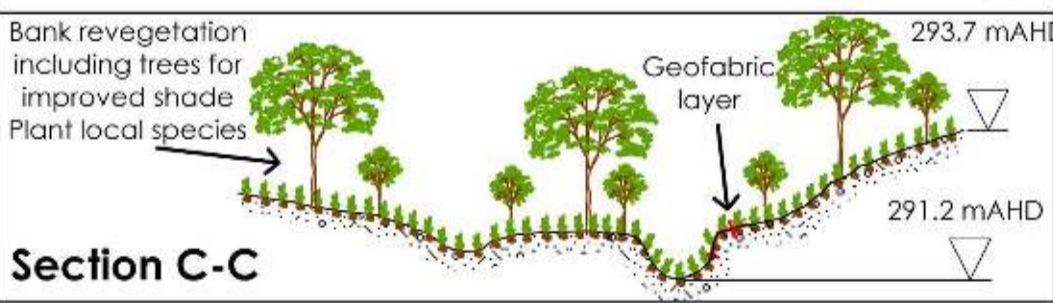
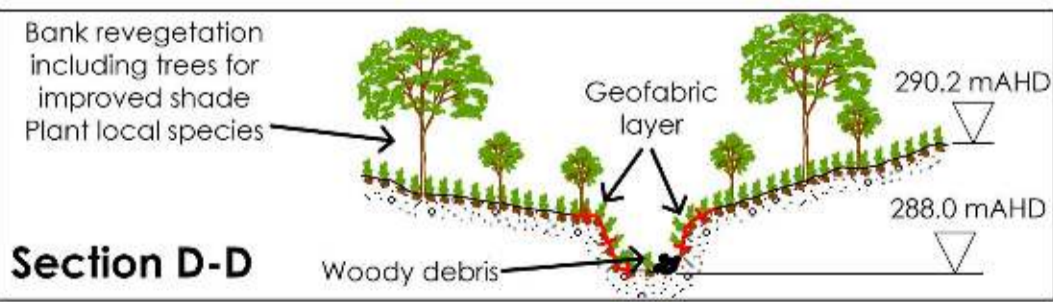
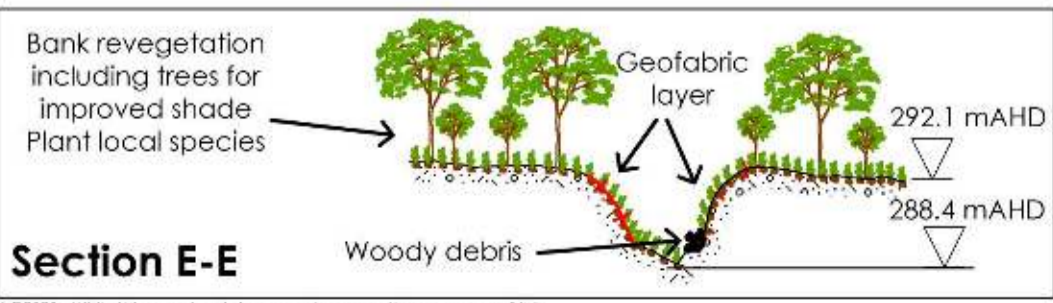
Figure 2: Popanyinning site concept - Cross section plan

- Minor modification of bank shape may be required for vehicle/equipment access and/or local stabilization.
- Geo-fabric (slopes steeper than 1:3):
 - o Install below summer water levels (under rock pitching).

- o Install around existing vegetation where required.
 - o Laid in direction of flow at base of slopes (to 1m above summer w.l.).
 - o Roll geofabric downslope over remainder of bank.

- o Bury at top of bank.
 - o Pin as per manufacturer requirements.
 - o Overlap geo-fabric maps by 100mm.
 - o Include slits for planting.
- Rock pitching (on slopes steeper than 1:3 and higher than 1m):

- o d50 size of 200mm.
 - o Hard, durable rocks that are not susceptible to weathering.
 - o Larger rocks to be installed at the base of the slopes.
 - o Smaller rocks to be used to fill gaps and form tightly packed layer.

- o Two layers of rocks.
 - o Rock pitching grade >1:2.
 - o Rock pitching to be installed to at least 1m above summer w.l.
 - o Toe trench, up to 400mm (back filled with rocks).

- Woody debris (tree trunks, collapsed trees) may be used instead of rock pitching depending on local conditions, access, or availability of material:
 - o Pinned/anchored to (or buried into) the bank.

- o Aligned in a downstream direction.
 - o Use only native species.

1. Temporary fencing will be installed to protect sections of comprehensive and demonstration revegetation.
2. Rock pitching will be installed to base and sides of steps (as per Figure 1 and Figure 2).
3. Geofabrics will be installed to banks identified for bank stability measures (as per Figure 1).
