Hotham-Williams River Action Plan

Williams Detailed site plan

**Prepared for
Peel-Harvey Catchment Council**

By Urbaqua

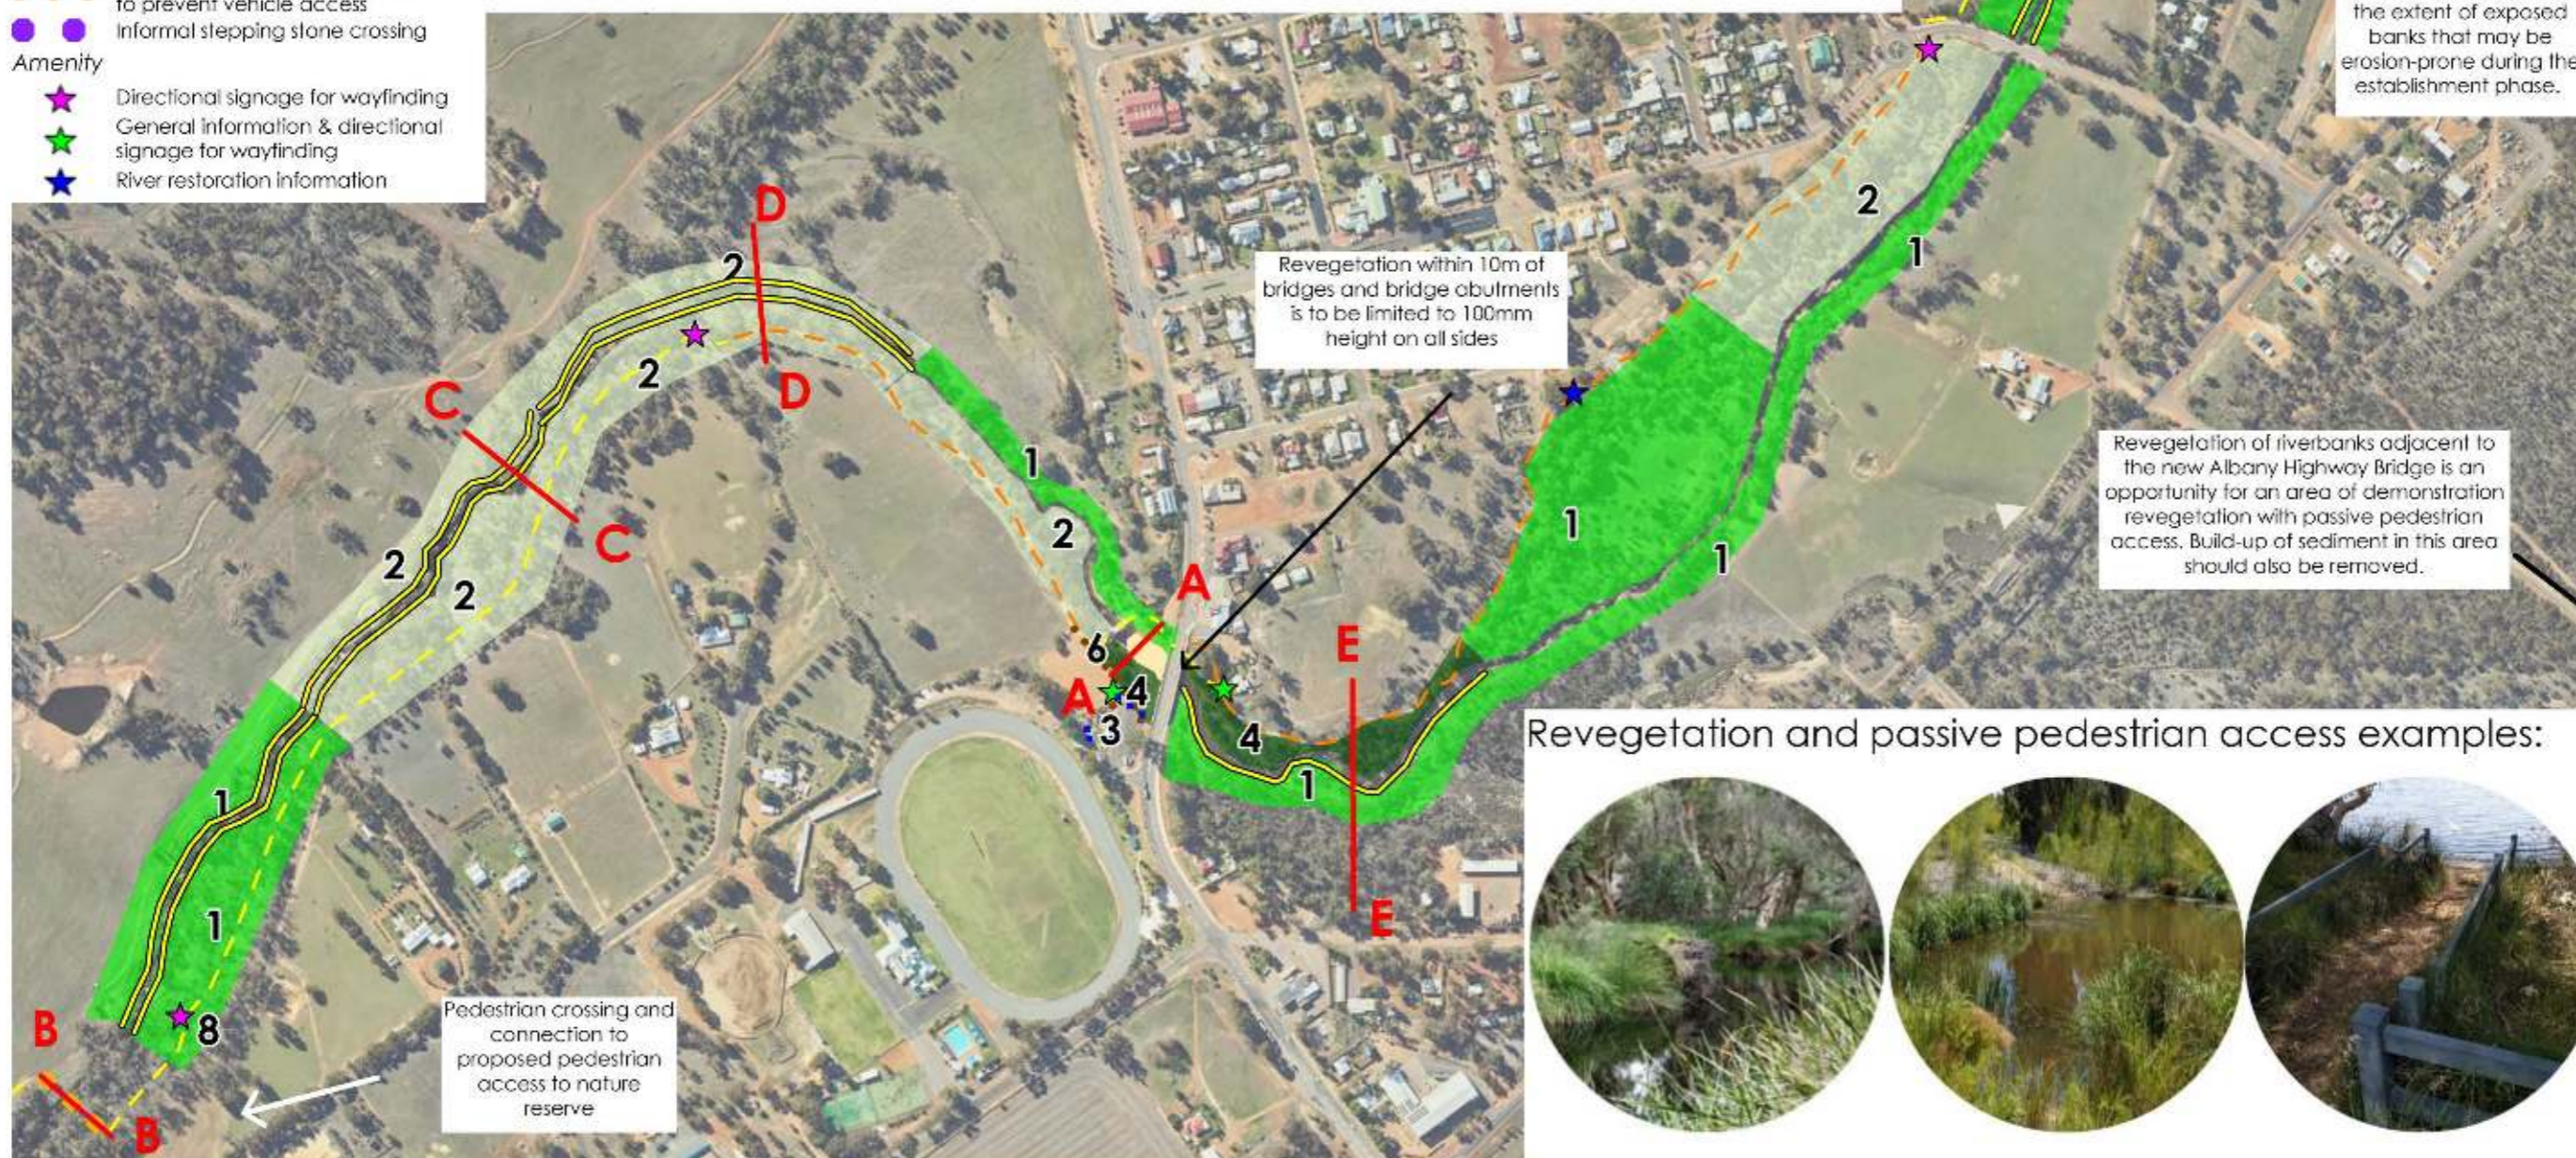
Figure 1: Williams Site Concept - Restoration Plan

1. Revegetation – comprehensive weed removal and revegetation of minimum 10m riparian buffer in these areas (30m preferred where tenure and land-use allow).
2. Revegetation – spot removal of weeds and problem exotics, replacement with native species where necessary.
3. Trees for increased canopy and amenity and shelters / picnic facilities on the river foreshore.
4. Revegetation – accessible demonstration area for revegetation with higher value species incorporating explanatory signage and trees to improve riparian shading.
5. Investigate and remove rubbish from river channel and banks – general clean-up as required.
6. Network of footpaths with wayfinding to encourage community use and connection with the River.
7. Install informal crossing point (eg: stepping stones).
8. Install pedestrian bridge to facilitate footpath connection to nature reserve.

- Comprehensive weed removal in degraded areas with spot weed removal and control of exotics in other areas (see Figure 1).
- Bank stabilisation works (See Figure 3 for examples). Where banks are modified but unable to achieve a 1:3 grade, some form of matting or other stabilisation is likely to be required. This may also be required where the sediment is sandy or otherwise unstable. In general:

1. Temporary fencing will be installed to protect sections of comprehensive and demonstration revegetation.
2. Geofabrics will be installed to banks identified for bank stability measures (as per Figure 1).

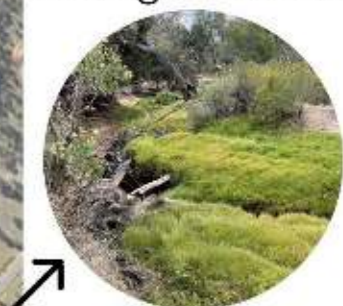
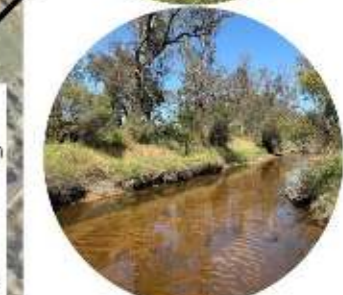
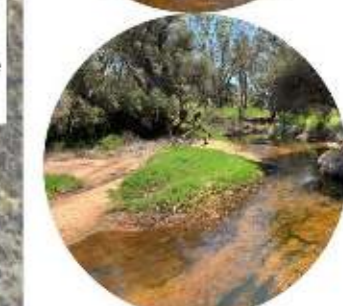
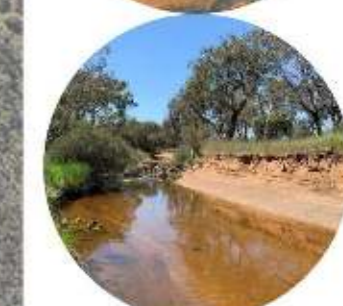
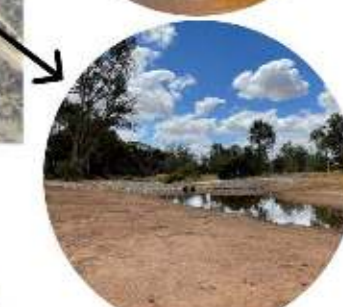
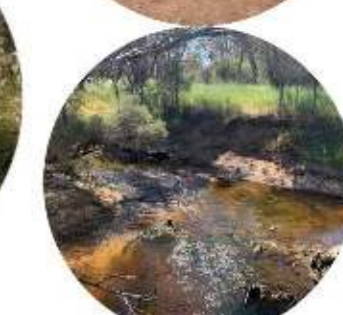
Existing conditions:

Removal of larger invasive weeds, including areas of couch grass should be undertaken in small sections and revegetated immediately to minimise the extent of exposed banks that may be erosion-prone during the establishment phase.

Revegetation of riverbanks adjacent to the new Albany Highway Bridge is an opportunity for an area of demonstration revegetation with passive pedestrian access. Build-up of sediment in this area should also be removed.

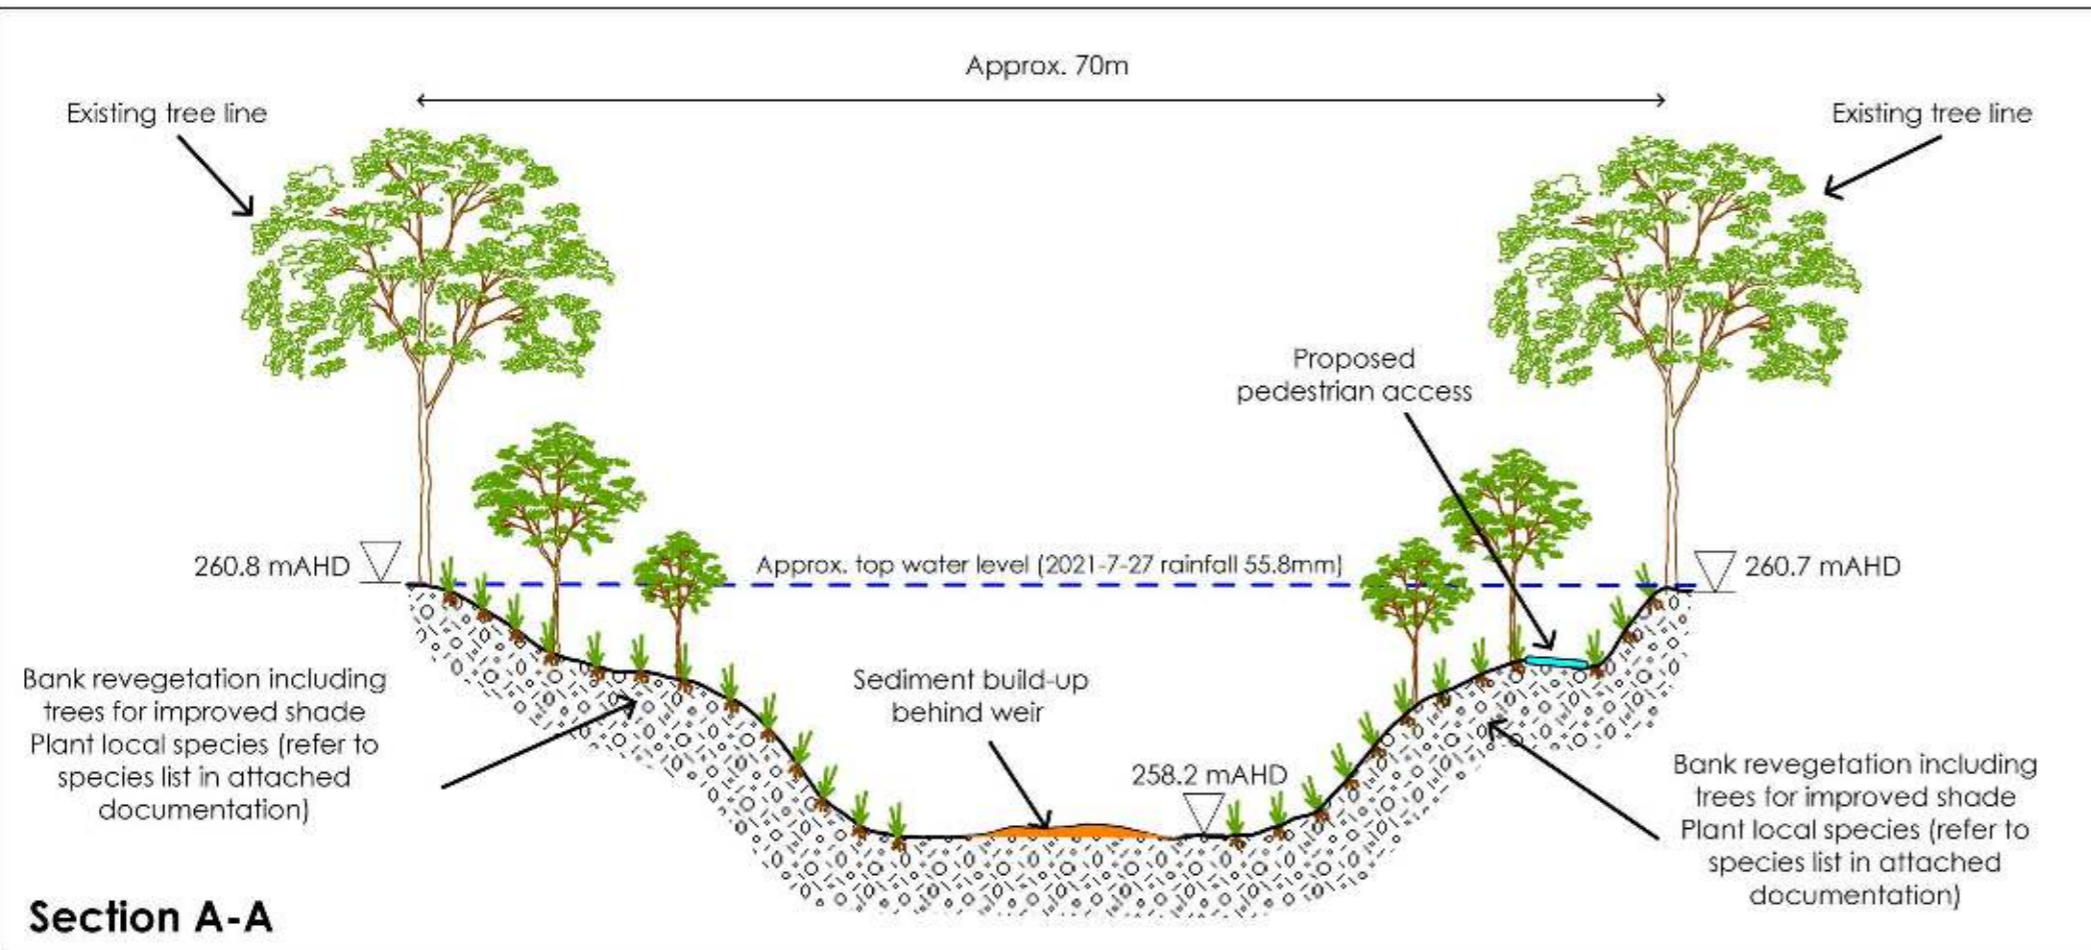
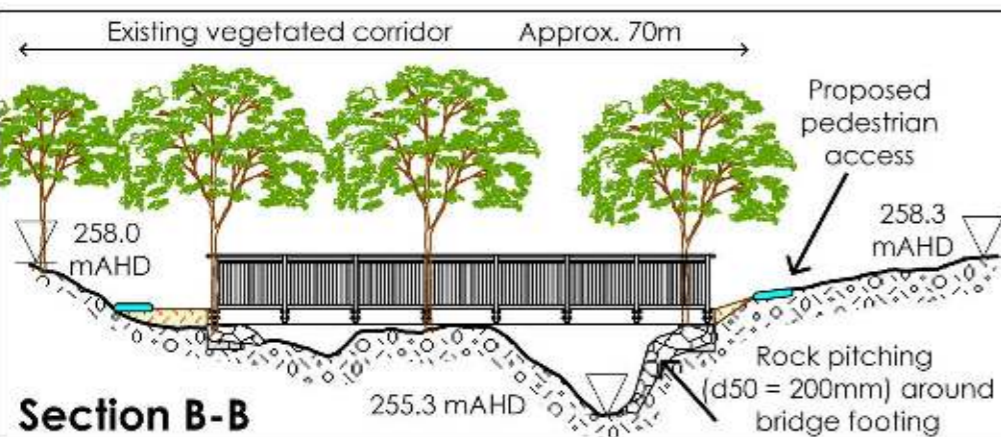
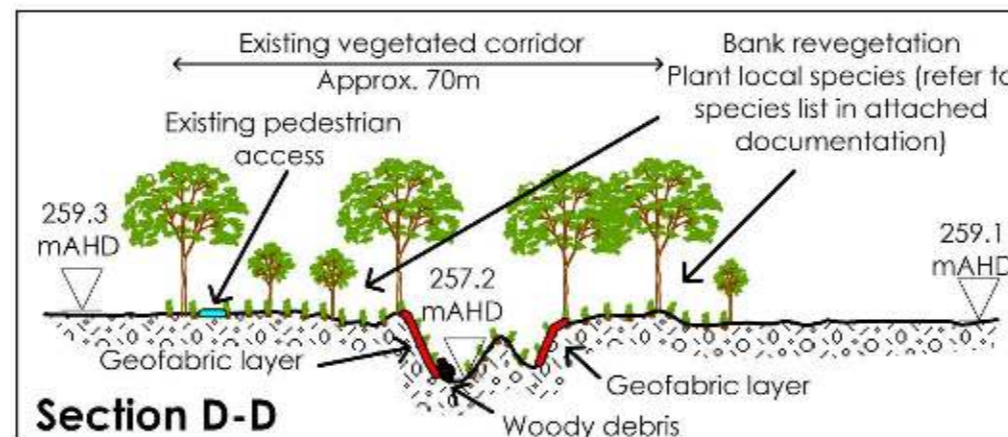
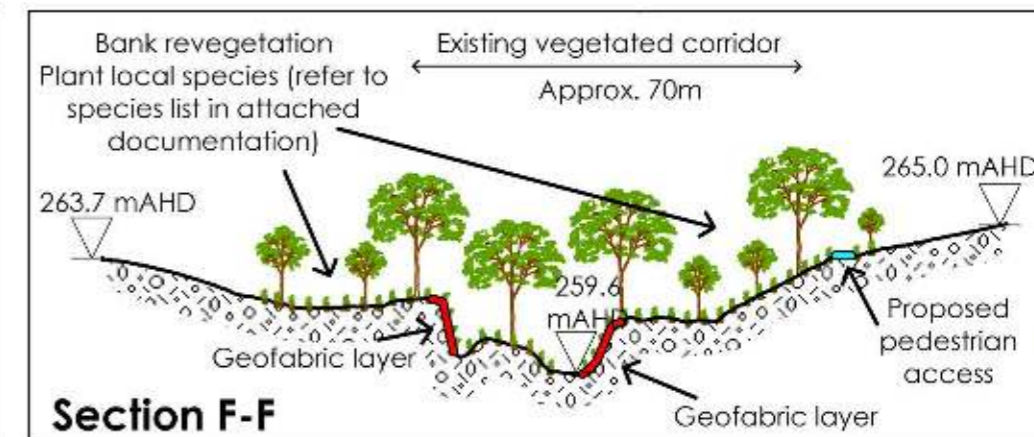
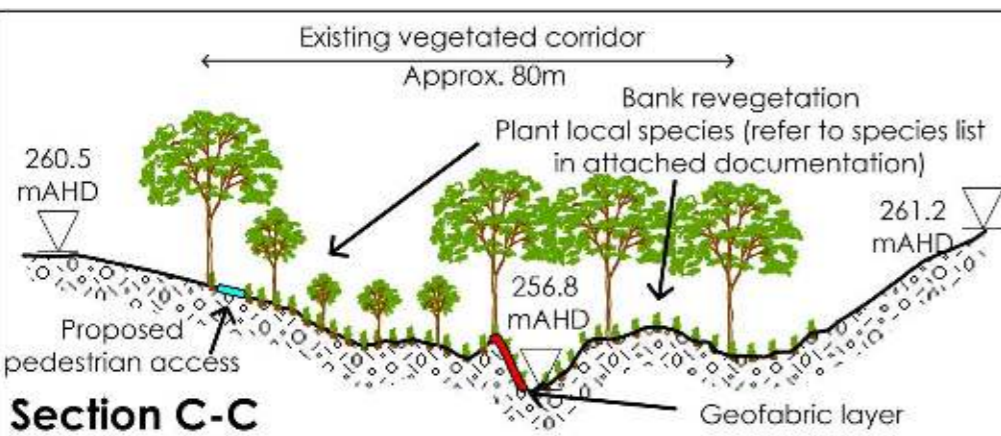
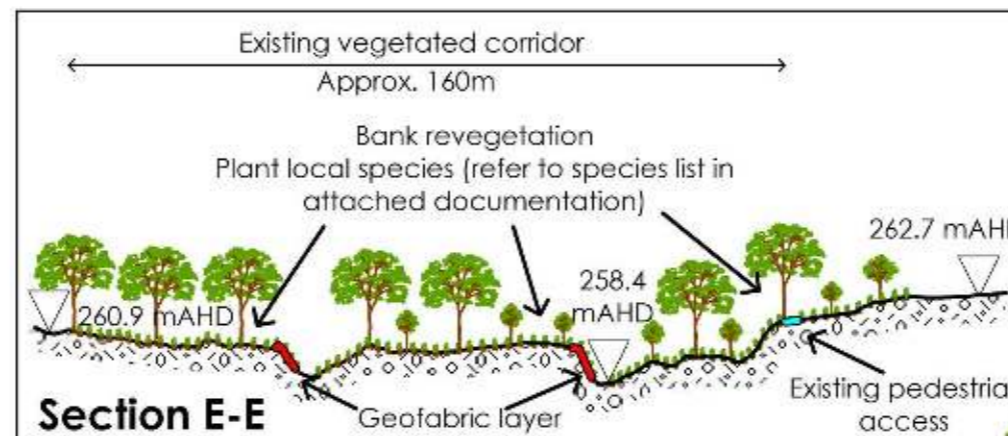
Figure 3: Williams Site Concept - Cross Section Plan

- Minor modification of bank shape may be required for vehicle/equipment access and/or local stabilization.
- Geo-fabric (slopes steeper than 1:3):
 - o Install below summer water levels (under rock pitching).

- o Install around existing vegetation where required.
 - o Laid in direction of flow at base of slopes (to 1m above summer w.l.).
 - o Roll geofabric downslope over remainder of bank.

- o Bury at top of bank.
 - o Pin as per manufacturer requirements.
 - o Overlap geo-fabric maps by 100mm.
 - o Include slits for planting.
- Rock pitching (around structures and on slopes steeper than 1:3 and higher than 1m):

- o d50 size of 200mm.
 - o Hard, durable rocks that are not susceptible to weathering.
 - o Larger rocks to be installed at the base of the slopes.
 - o Smaller rocks to be used to fill gaps and form tightly packed layer.

- o Two layers of rocks.
 - o Rock pitching grade >1:2.
 - o Rock pitching to be installed to at least 1m above summer w.l.
 - o Toe trench, up to 400mm (back filled with rocks).

- Woody debris (tree trunks, collapsed trees) may be used instead of rock pitching depending on local conditions, access or availability of material:
 - o Pinned/anchored to (or buried into) the bank.

- o Aligned in a downstream direction.
 - o Use only native species.

Not to scale
Levels shown are approximate
based on LiDAR elevations

- Banks steeper than 1:3 should be gently regraded where possible without damage to existing vegetation.
 - Banks up to approx. 1m high and steeper than 1:3 that cannot be regraded should be covered with pinned geofabric prior to revegetation with native riparian species.

- Banks greater than 1m high and steeper than 1:3 that cannot be regraded should be stabilised at the toe with rock revetment or secured woody debris, covered with pinned geofabric above and vegetated with native riparian species.
