The River Action Plan (RAP) has been prepared to provide a basis for rehabilitation works and a summary of baseline conditions to reference future works against. The document was prepared in partnership between the Peel-Harvey Catchment Council and Urbaqua, with funding provided by the Aloca Foundation under the Connecting Corridors and Communities: Restoring the Serpentine River project. The RAP addresses approximately 38 km of river from the Lowlands Nature Reserve to the Peel-Harvey Estuary, divided into eight (8) reaches that vary from meandering natural channels, to artificial drains to estuarine systems.

The RAP was prepared based on field inspections of the reaches and desktop analysis of aerial imagery and previous investigations. Each reach was assessed in accordance with the Department of Water and Environmental Regulation's *River Restoration Manual* (WRC, 1999), specifically the Pen-Scott method that grades foreshore between grades A (pristine) and D (ditch). Scoring of the foreshore condition allowed for determination of priority areas for rehabilitation.

Peel Harvey Catchment Council - Serpentine River Action Plan Figure 1 - Serpentine River Action Plan Reaches

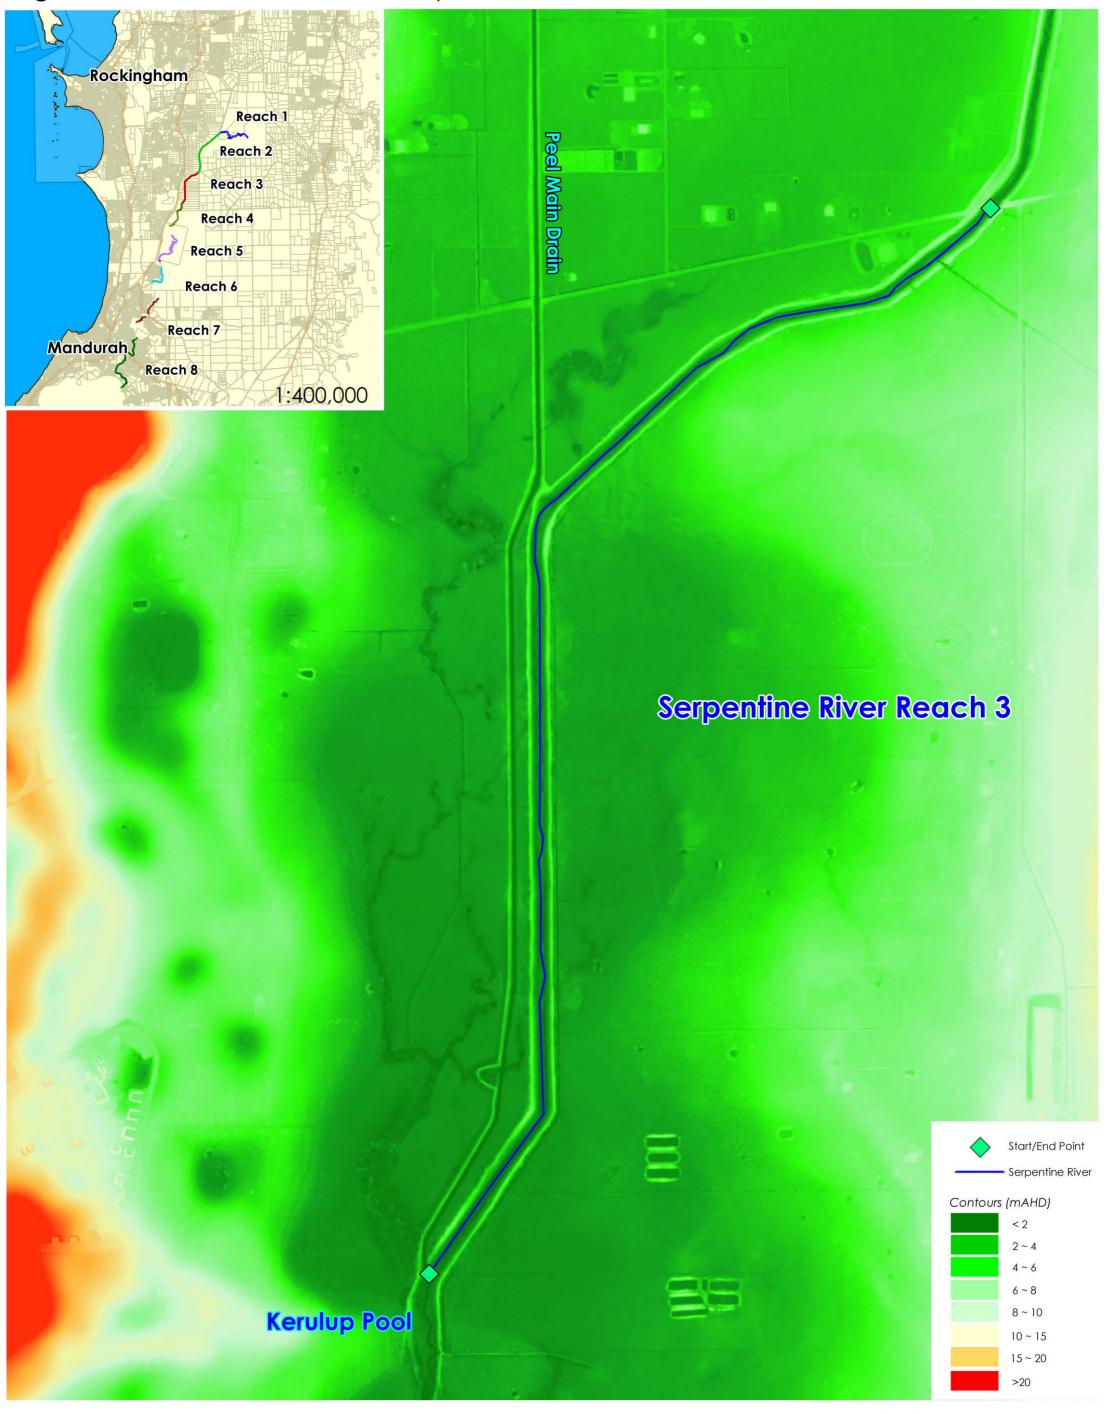
Peel Harvey Catchment Council - Serpentine River Action Plan Figure 12 - Reach 3 Elevation Map

As shown in Figure 12, the levee banks are significantly higher than the surrounding low-lying landscape. Figure 12 also shows the presence of former channels and wetlands which reflects the pre-European form of the river through this area. The highly modified channel form is generally stable however there are extensive areas of bare ground with limited vegetation. Weeds were also identified on the levee banks and within the main channel.

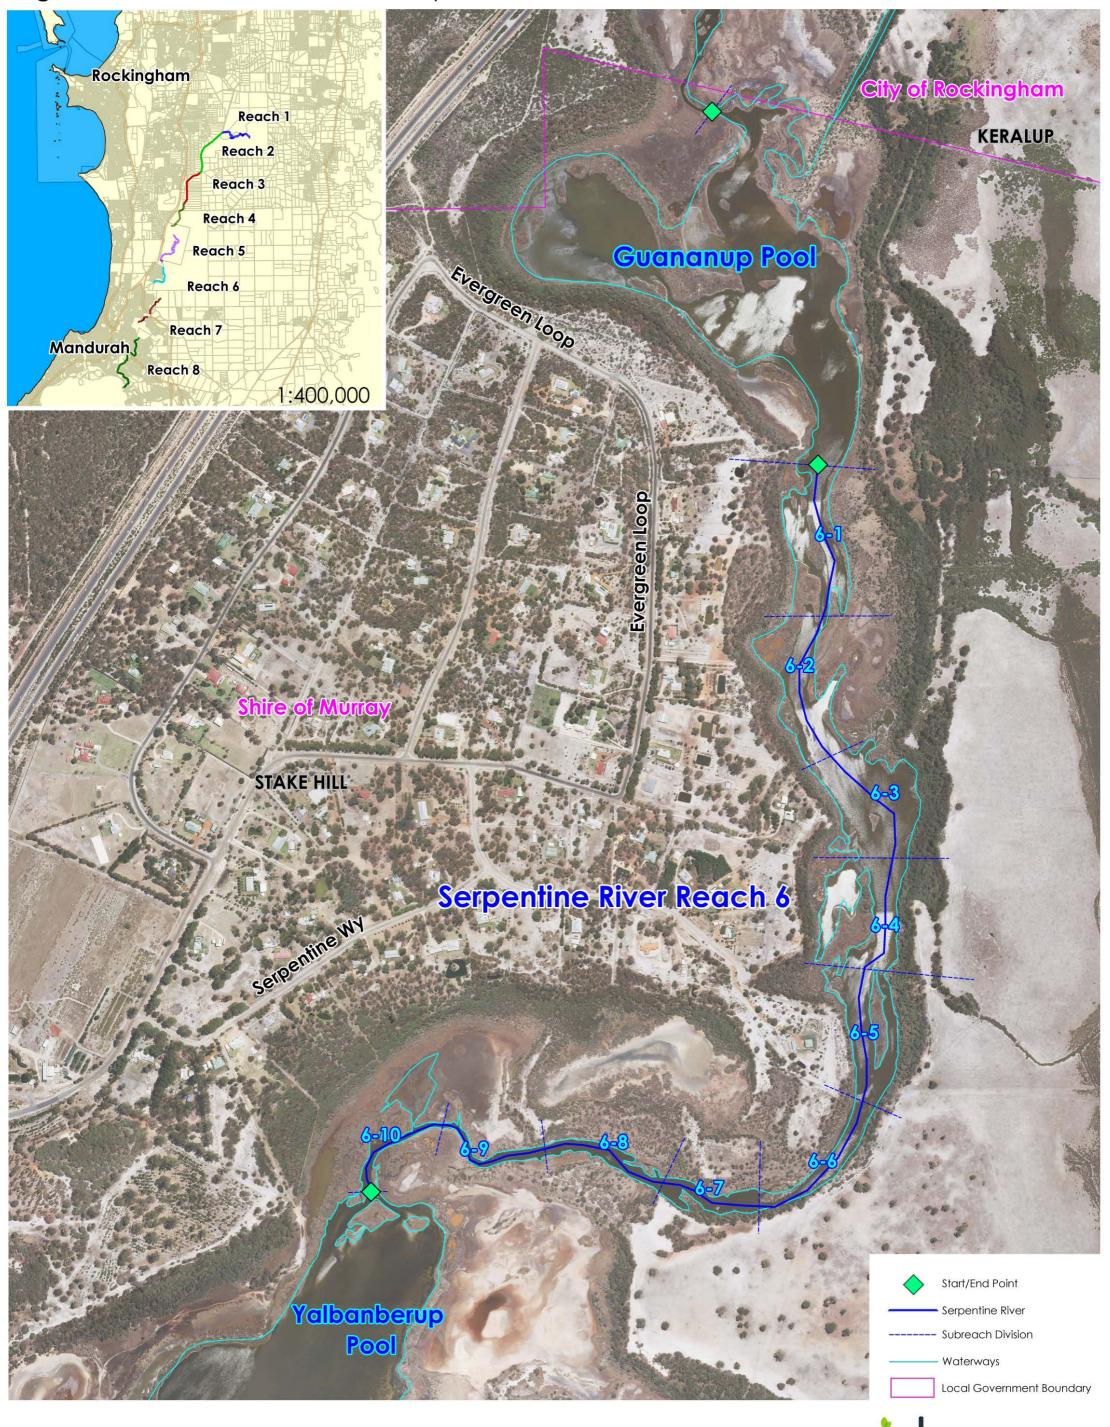
Peel Harvey Catchment Council - Serpentine River Action Plan Figure 21 - Reach 6 Location Map

such as water hyacinth that were noted upstream. Aerial imagery (Figure 21) and LIDAR data (Figure 22) suggests that there would be limited erosion throughout the reach. Reach 7 (downstream) has a similar channel form and erosion was associated with human access only. The vegetation and land ownership limits this potential in Reach 6.				
Erosion					
Other Issues	er Issues During a separate inspection in 2019, a dead Rakali was identified in the downstream section.				
Community and Cultural Values	Local Bindjareb Noongar Elders and Representatives will provide knowledge and advice on each site, its cultural significance and values. Please refer to section 2.3 of this document to ensure all processes and procedures are followed. Community value of this reach is limited by the lack of public access. Although there is increased access opportunities compared within upstream reaches, recreation generally consists of kayaking.

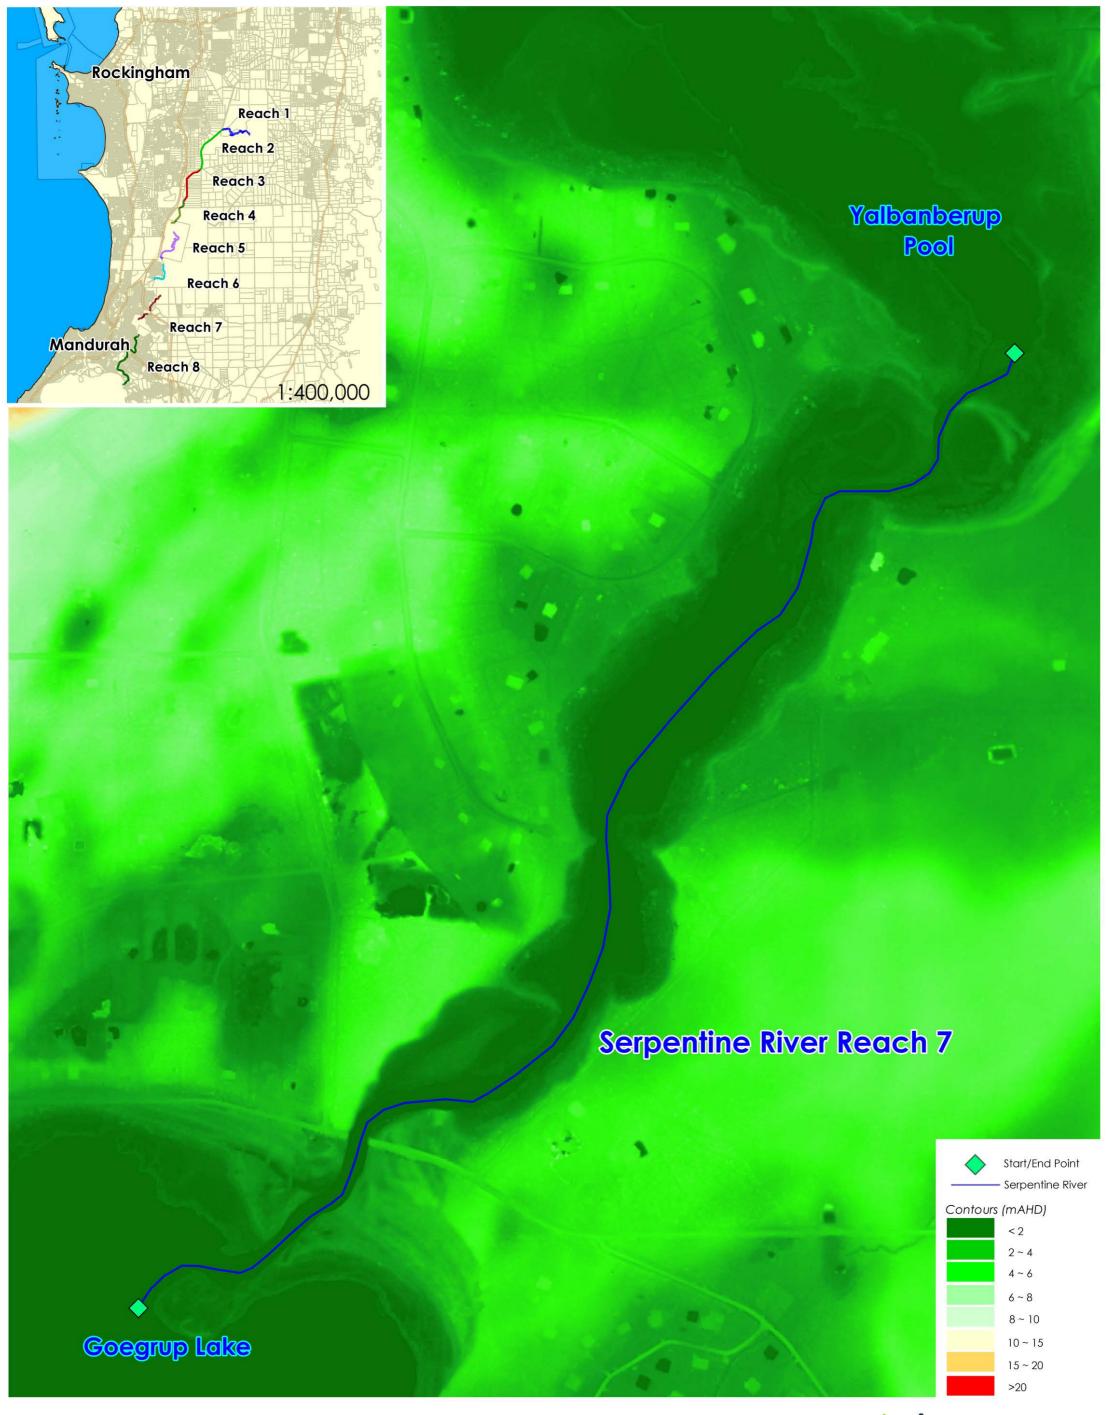
Peel Harvey Catchment Council - Serpentine River Action Plan Figure 25 - Reach 7 Elevation Map

The river has not been significantly modified historically apart from the Kwinana Freeway construction. The upstream and downstream subreaches are relatively narrow and meandering, while the middle sub-reaches are approximately 200 m wide. As shown in Figure 25, the banks and immediate floodplain are low-lying, with tidal flats at the upstream end. There are multiple informal access points to the river, demonstrating the recreation value of this reach in particular kayaking.
