# Lower Murray River Action Plan

REVIEWED AND UPDATED 2014

Original document produced by the Department of Environment 2003 Updated by the Peel-Harvey Catchment Council 2014

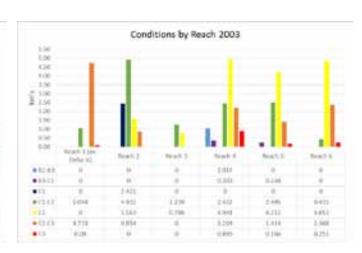
### Foreshore Condition Comparison 2003 v 2014

Below illustrates the approximate overall changes to conditions for 2003 compared to 2014.

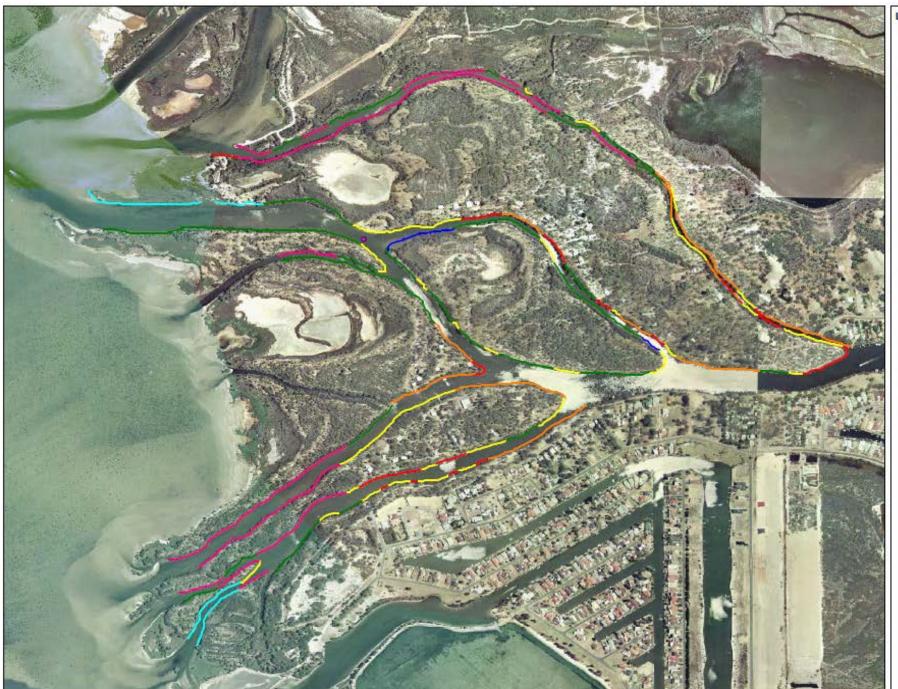
Reach 1- Murray River Delta Islands - Foreshore Condition Assessment Map 2003

Bank Stability & Erosion	Banks are generally stable due to extensive rock and log walling. However, increased tidal activity from the Dawesville Channel has caused clay banks to slump and some older areas of walling are degrading. Increasing human activity has resulted in the loss of sedges, rushes and upperstorey vegetation and an increase in foreshore erosion. Baffle boards have been placed at points along this section. Most have failed to stop erosion and add to the stability of the reach. Deposition is evident between Cooleenup and Jeengarnyeejip Islands.
Habitat	The Delta Islands provide a variety of foreshore habitats for terrestrial animals including roosting sites. Instream habitat is varied as the braided channel provides a variety of widths and depths, as does the tidal influence. There is a significant amount of instream woody debris. East of the Delta Islands the reach is straight. Some instream woody debris exists along the water-edge providing roosting sites but rock and log walls have replaced much of the natural embankment. Foreshore habitat is sparse due to the removal of vegetation.

Other Comments	Unauthorised access by small boats is resulting in the destruction of fringing vegetation and erosion. Increased tidal activity since the construction of the Dawesville Channel, impacts of storm surges and flooding has led to a loss of vegetation along this reach. Illegal activity was evident at certain points along the reach, such as illegal clearing of vegetation and new jetty construction.  Where baffle boards have been installed along this reach in the past appeared to have failed to improve bank stabilisation.

- 9. Provide walk and cycle paths to minimise human impact along foreshore reserves.
- 10. Produce and implement a weed management plan for all reserves and Delta Islands, focusing on areas that can be effectively managed.
- 11. Introduce poo bags and erect signage to ensure all dogs are restrained on a leash in foreshore reserves to protect riparian vegetation and reduce excrement fouling public reserves and entering the river.
- 12. Monitor and review recreational facilities and impacts along reserves.
- 13. Include drainage mapping to identify point source pollution and possible streamlining, retrofitting, etc activities.
- 14. Identify and sign historical landmarks.
- 15. Form working groups to assist in maintaining foreshore areas
- 16. Engage community to assist with local councils to implement management plans
