# Peel-Harvey Catchment Council - Hotham-Williams River Action Plan Figure 1: Ranford Pool Site Concept - Restoration Plan

# 1 SITE DESCRIPTION

The restoration concept (Figure 1, Figure 2 and Figure 3) is informed by the desktop assessment, site visits and stakeholder consultation. It is an extension of the previous restoration works, which were focussed on improving access to the pool, increasing amenity, and providing low-key community facilities.

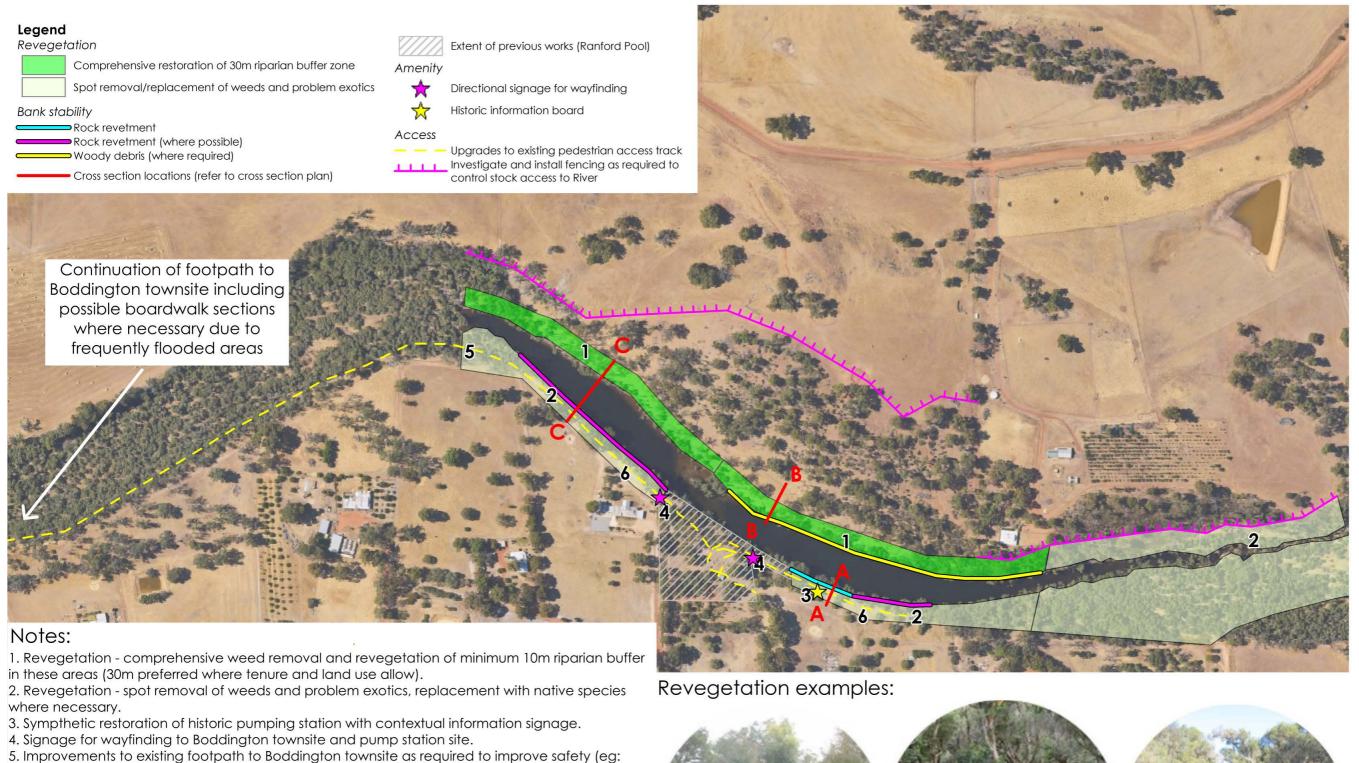
Project activities outside of the main focal areas on public land will be in close consultation with neighbouring landholders.

Fencing should be located outside of the riparian zone above the top-of-bank and at least 15m

from the high water mark in accordance with PHCC minimum fencing requirements.

The proposed works are detailed in Figures 1, 2 and 3 as follows.

- Comprehensive weed removal in degraded areas with spot weed removal and control of exotics in other areas (see Figure 1).
- Bank stabilisation works (See Figure 3 for examples). Where banks are modified but unable to achieve a 1:3 grade, some form of matting or other stabilisation is likely to be required. This may also be required where the sediment is sandy or otherwise unstable. In general:

- 1. Temporary fencing will be installed to protect sections of comprehensive and demonstration revegetation.
- 2. Rock pitching will be installed to banks identified for "Rock Revetment" with 100% coverage, to banks identified for "Rock revetment (where possible)" with 50% coverage (as per Figure 1).
- Geofabrics will be installed to banks identified for bank stability measures (as per Figure 1).

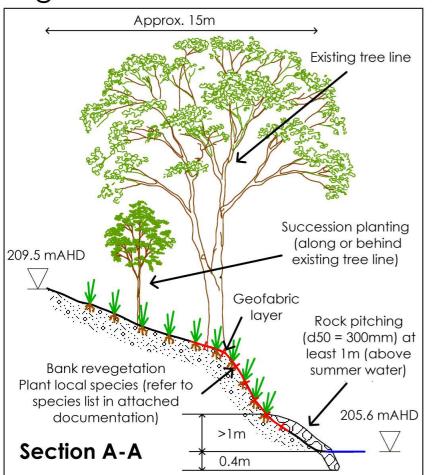
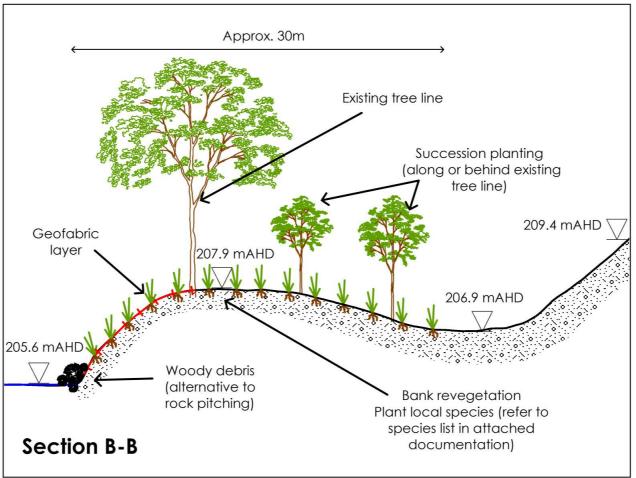
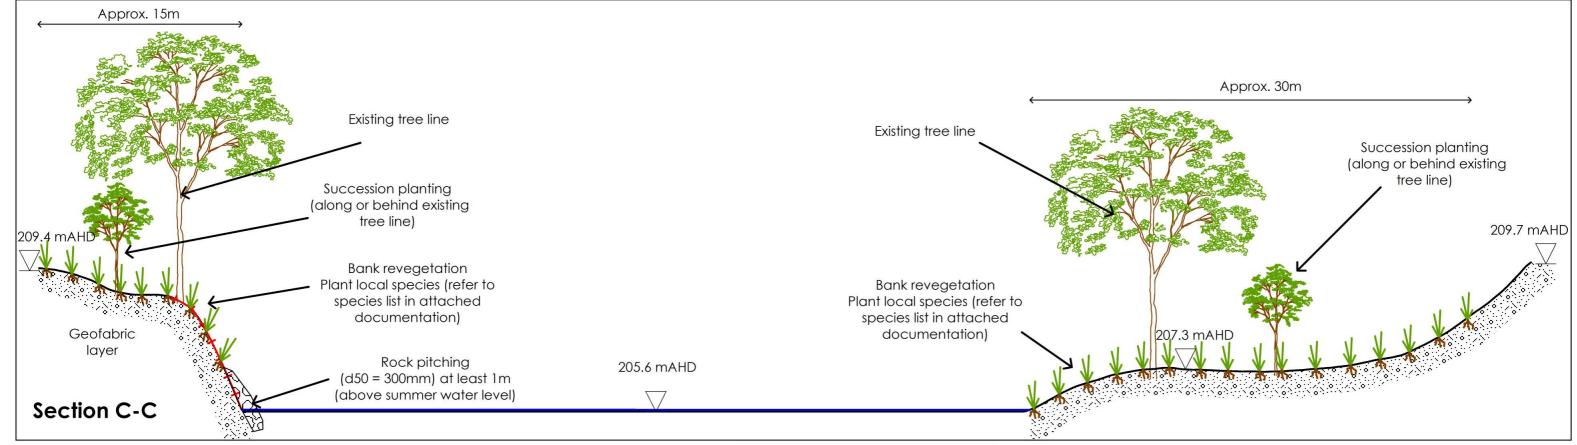
# Peel-Harvey Catchment Coucil - Hotham-Williams River Action Plan Figure 3: Ranford Pool Site Concept - Cross Section Plan

# Notes:

Minor modification of bank shape may be required for vehicle/ equipment access and/or local stabilization.

- Woody debris (tree trunks, collapsed trees) may be installed instead of rock pitching depending on local conditions, access or availability of material:

- o Pinned/anchored to (or buried into) the bank.
- o Aligned in a downstream direction.
- o Use only native species.

- Banks steeper than 1:3 should be gently regraded where possible without damage to existing vegetation.
  - o Banks up to approx. 1m high and steeper than 1:3 that cannot be regraded should be covered with pinned geofabric prior to revegetation with native riparian species.
